Bulkhead Monitoring Report

**Morgan Creek Harbor
Isle of Palms, South Carolina**

June 18, 2019

Terracon Project No. 73055027

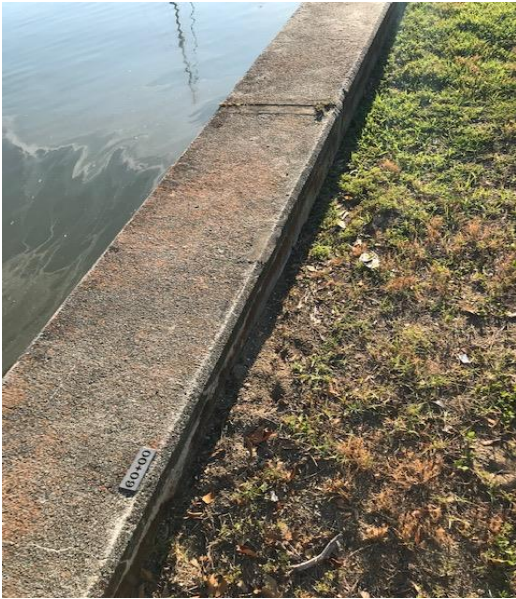
Station Number	Description	Photograph Number
60+00	3 to 4 inches deep, about 10' long	001
58+00	3 to 4 inches deep, about 10' long	004
57+45	6+/- inch deep, about 15' long	005
51+55	Sinkhole, 6 inch diameter at top, gets larger at base, about 3' deep	009
47+55	6+/- inch deep, about 5' long	010
45+50	Multiple locations, 3 to 4 inches deep, about 10' long	011
43+00	3 to 4 inches deep, about 5' long	013
41+50	3 to 4 inches deep, about 5' long	014

Photo 001 – subsidence, Station 60+00

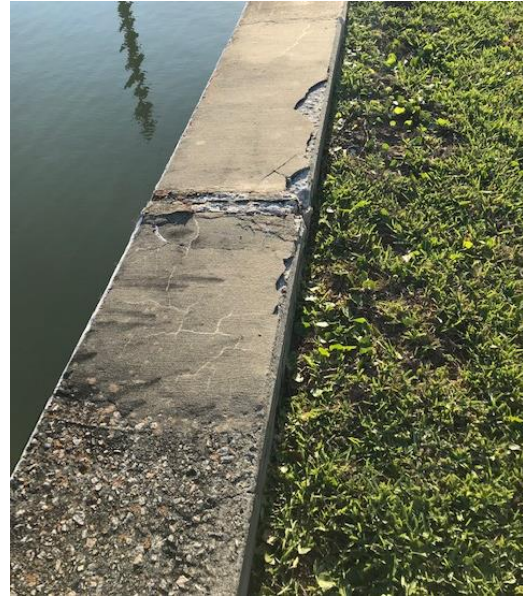
Topic	Overview Statement
Concrete Cap	The concrete filled cap for most part appears to be in fair to good conditions with several areas of surface damage, irregular cracks and joint spalling, exposed aggregates and age-related deterioration (photos 002, 003, 006 and 007 are examples of these conditions).
Flapper Valves	<p>The flapper valves appeared to be in good condition and functioning as intended at the time of our inspection. We did not notice any missing valves or clogged outlet gates.</p> <p>The inspection was performed during mid to low tide. During this time, the valves were noted to be opening and closing as intended.</p>
Tieback system	The tieback heads at the +4-level including the bearing plates, patch plates, rods and nuts show great deal of rust and surface corrosion. Marine growth is more abundant than in previous years and, in some cases, obscures the heads of the tiebacks at the zero level. This prevents a closer inspection of some of the zero level tiebacks and head assemblies.

Photo 002 – Cap deterioration/concrete spalling, Station 59+30

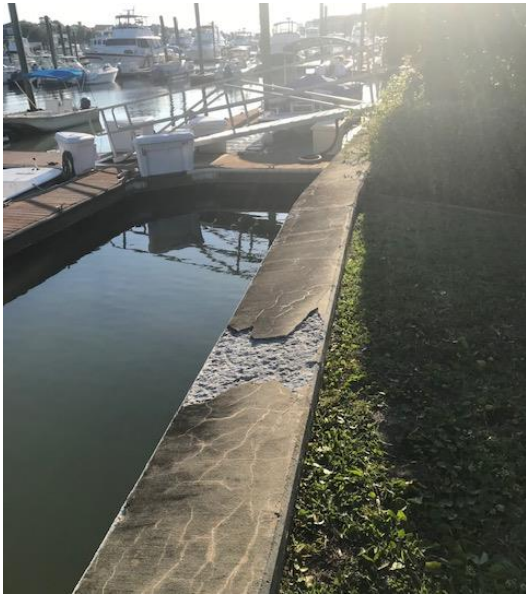
Photo 003 – cap deterioration, exposed aggregate, Station 59+00

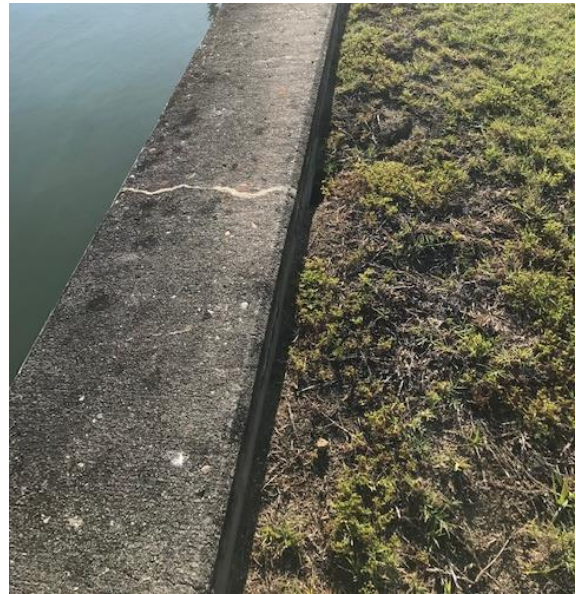
Photo 004 – subsidence, Station 58+00

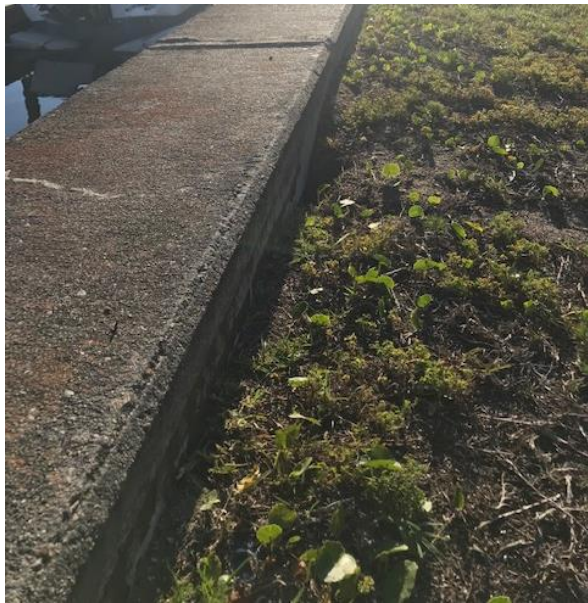
Photo 005 – subsidence, note sprinkler head nearby, Station 57+45

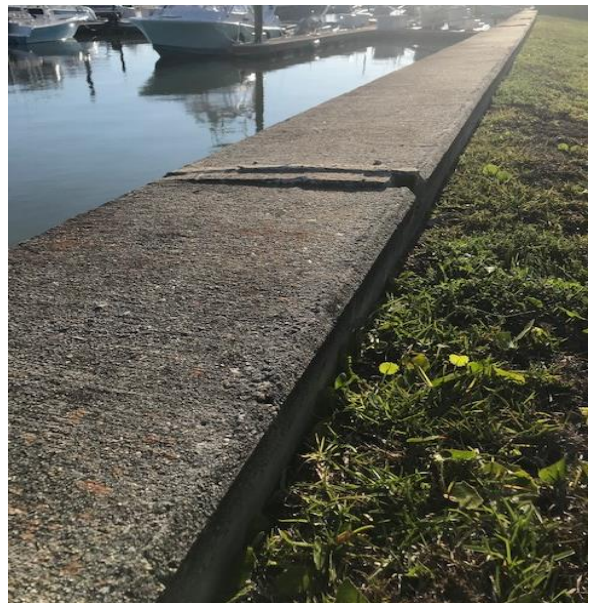
Photo 006 – cap joint displacement, Station 56+20

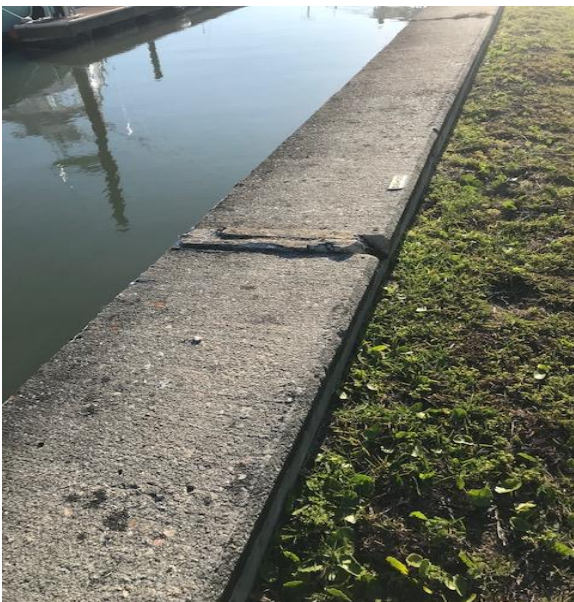
Photo 007- cap joint displacement, Station 56+00

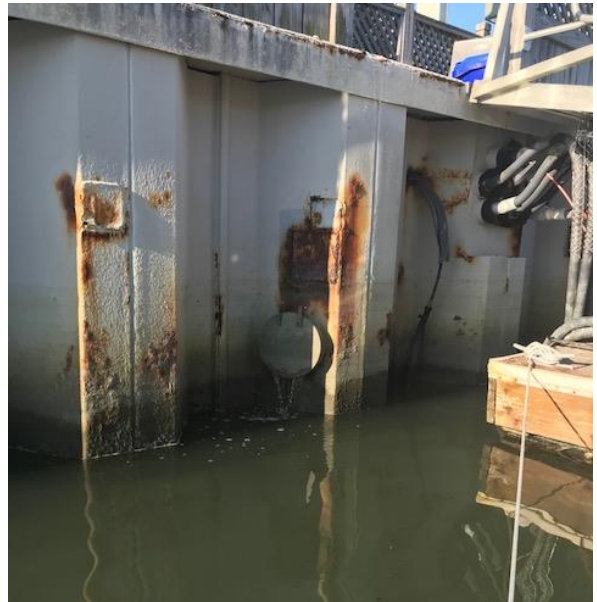
Photo 008 – Flapper valve, functioning mid tide

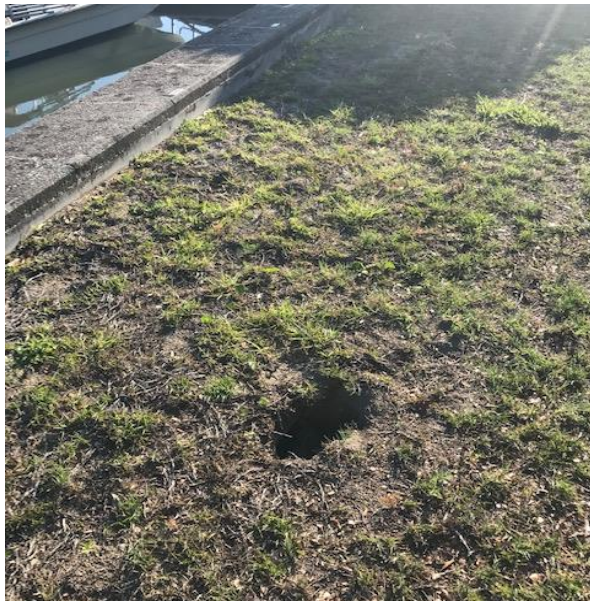
Photo 009 – sinkhole/backfill erosion, the center of sinkhole was about 3 feet from wall, Station 51+55, nearby marker Plate #9

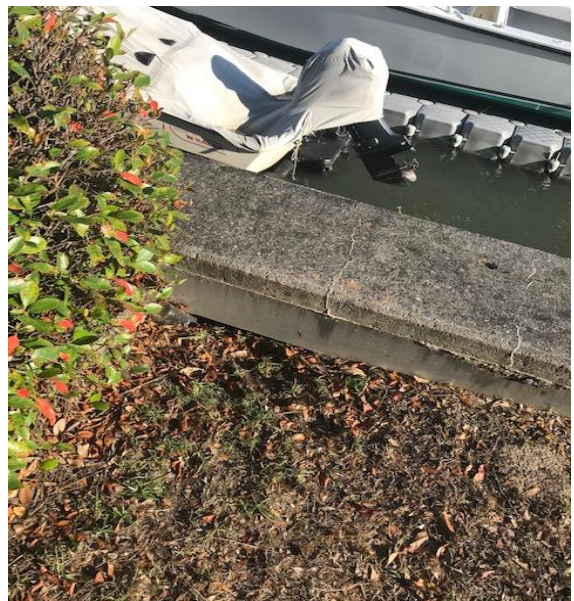
Photo 010 – subsidence, Station 47+55, note shrubs very near the wall.

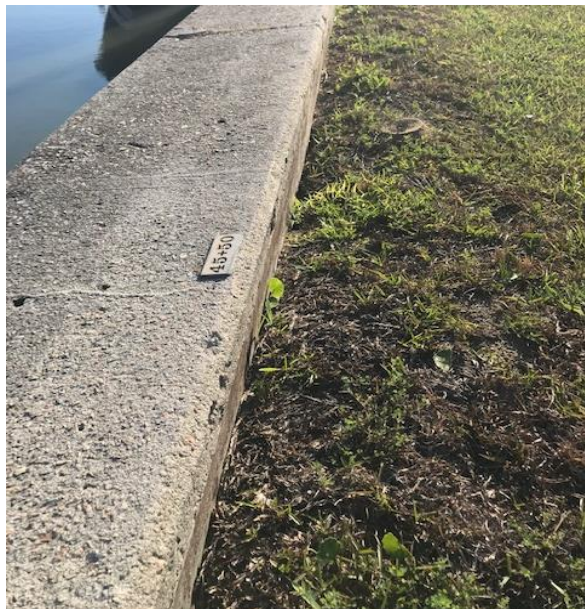
Photo 011- subsidence Station 45+50

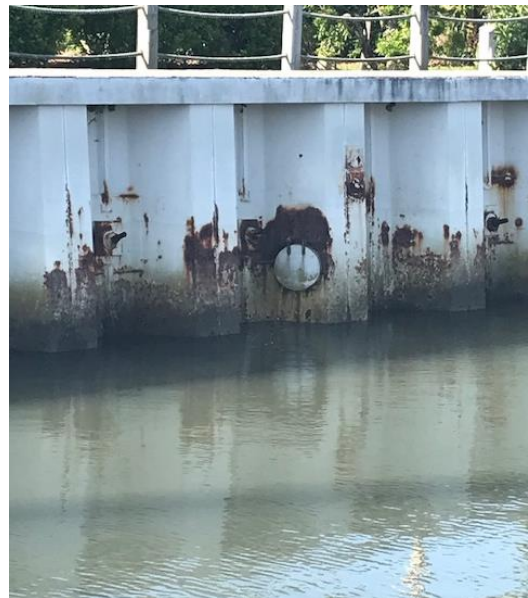
Corrosion	As has been stated in our previous monitoring reports, corrosion is an on-going issue that requires constant maintenance and attention. Corrosion appears to be more severe on the south side (A to J and Med Docks) as compared to the north side. The corrosion has gotten worse in last couple of years with development of new pin holes and enlargement of existing holes (Photos 020, 021 and 022 are typical examples). We understand that MCHA has been working with a corrosion consultant to address this issue.
House Keeping	<p>Shrubs, trees, and heavy privacy landscaping have been planted very close to the wall in Morgan Place between Station Markers 30+50 to 33+00. (Photo 015). The wall has a granular drainage system which allows relief of hydrostatic pressure behind the wall. Heavy roots growing into the drainage media behind the wall impedes drainage which may result in excessive hydrostatic pressure on the wall.</p> <p>Vegetation close to the wall also prevents adequate inspection and makes it difficult to conduct wall movement measurements. Considerations should be given to limit the vegetation within 10 feet of wall to grass only, if possible.</p>

Photo 012 – rust/corrosion (typical) around flapper valve, anchorage and bulkhead, Station 45+50

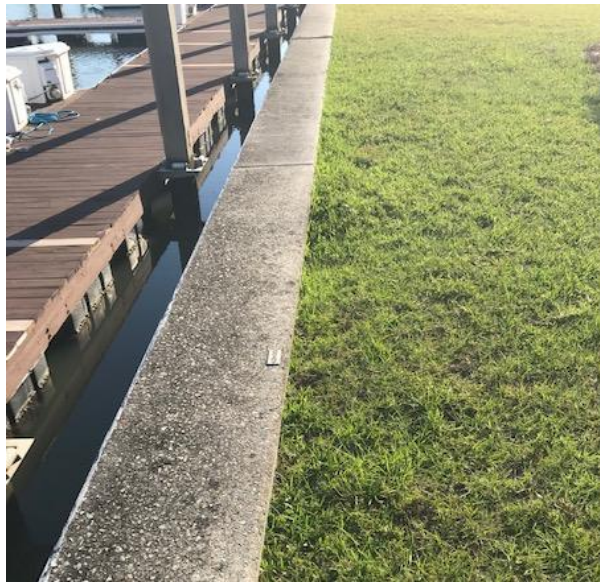
Photo 013- subsidence, Station 43+00

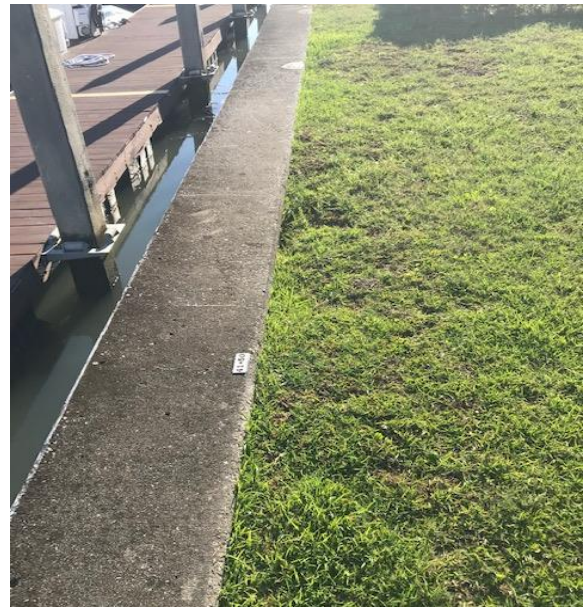
Photo 014 – subsidence, Station 41+50

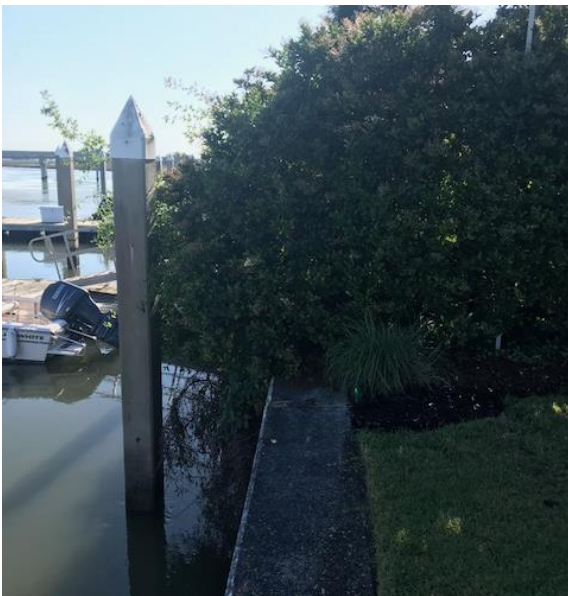
Photo 015 – Trees and shrubs have been planted very near to back side of the wall. The wall cap has completely been covered by overgrown shrubs and trees, Stations 30+70 to 33+00, typical

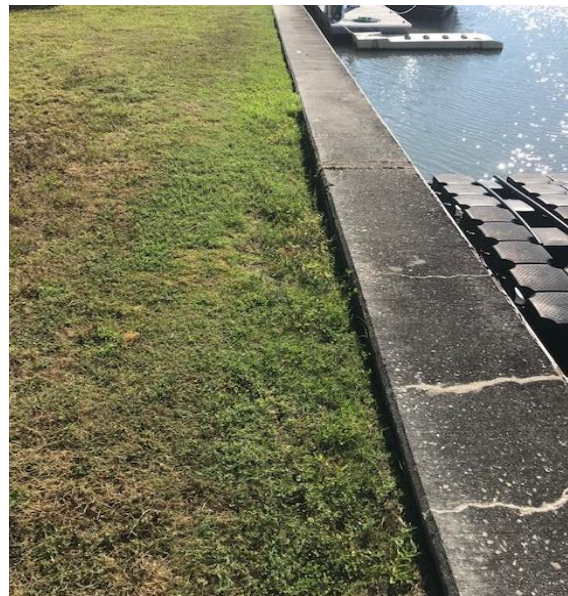
Station Number	Description	Photograph Number
15+20	Multiple locations, 3 to 4 inches deep, about 10' long	016
16+20	8 to 10 inches deep, about 15' long	017
17+30	6 to 8 inch deep, about 10' long	018
22+25	Multiple locations, 10+ inch deep, 10 to 15 feet long	019

Photo 016 – subsidence, Station 15+20

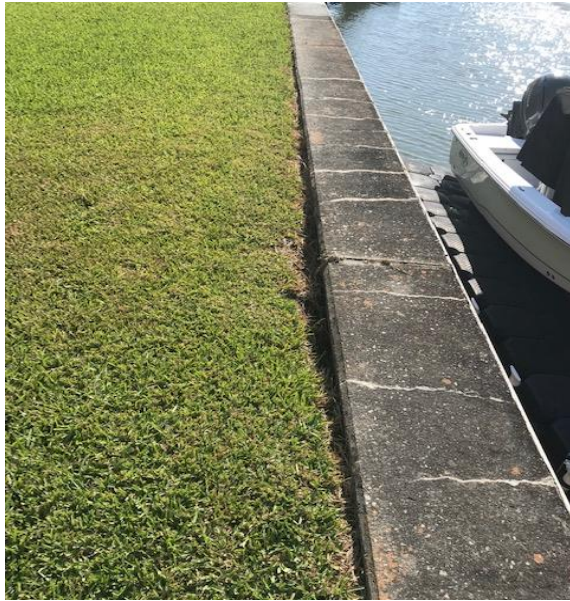
Photo 017 – subsidence, Station 16+20

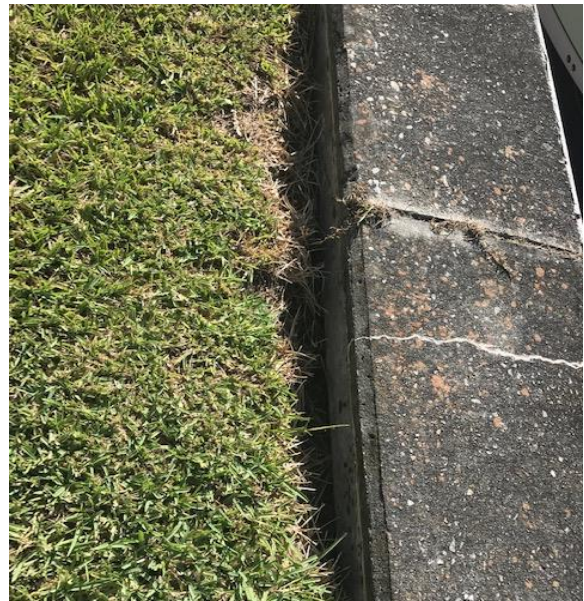
Photo 018 – subsidence, Station 17+30, note soil erosion below the cap flange.

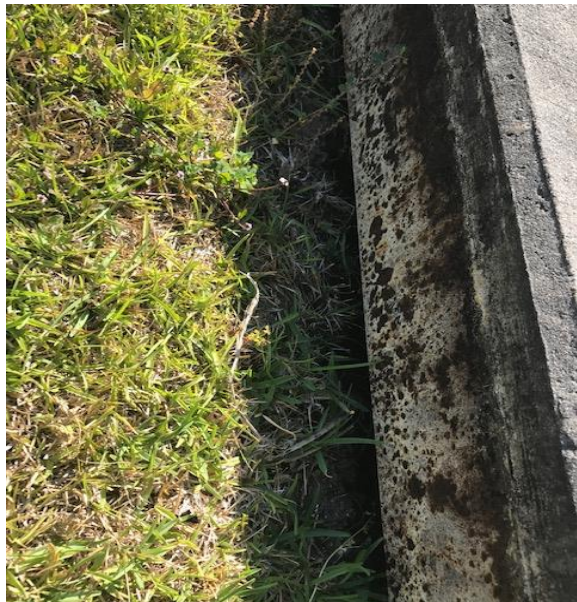
Photo 019 – subsidence, Station 22+25, deep erosion below cap.

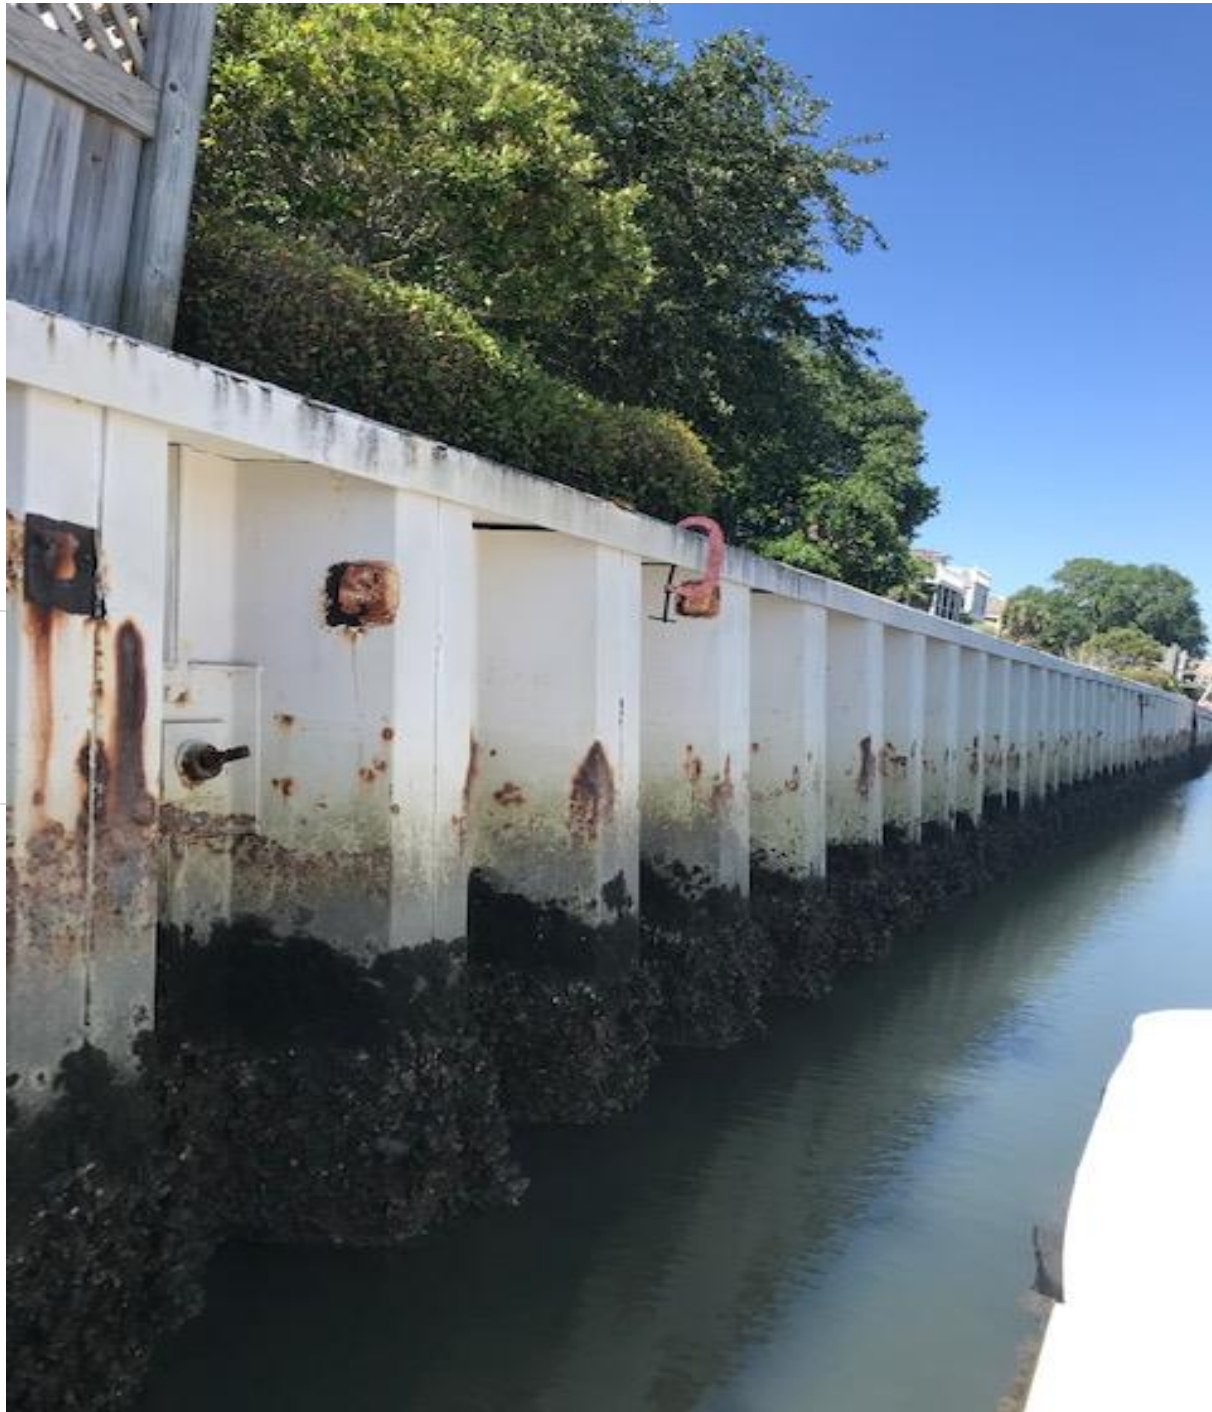
Photo 020- typical corrosion and marine build up. Note rust on patch plates. Also, numerous pinholes.

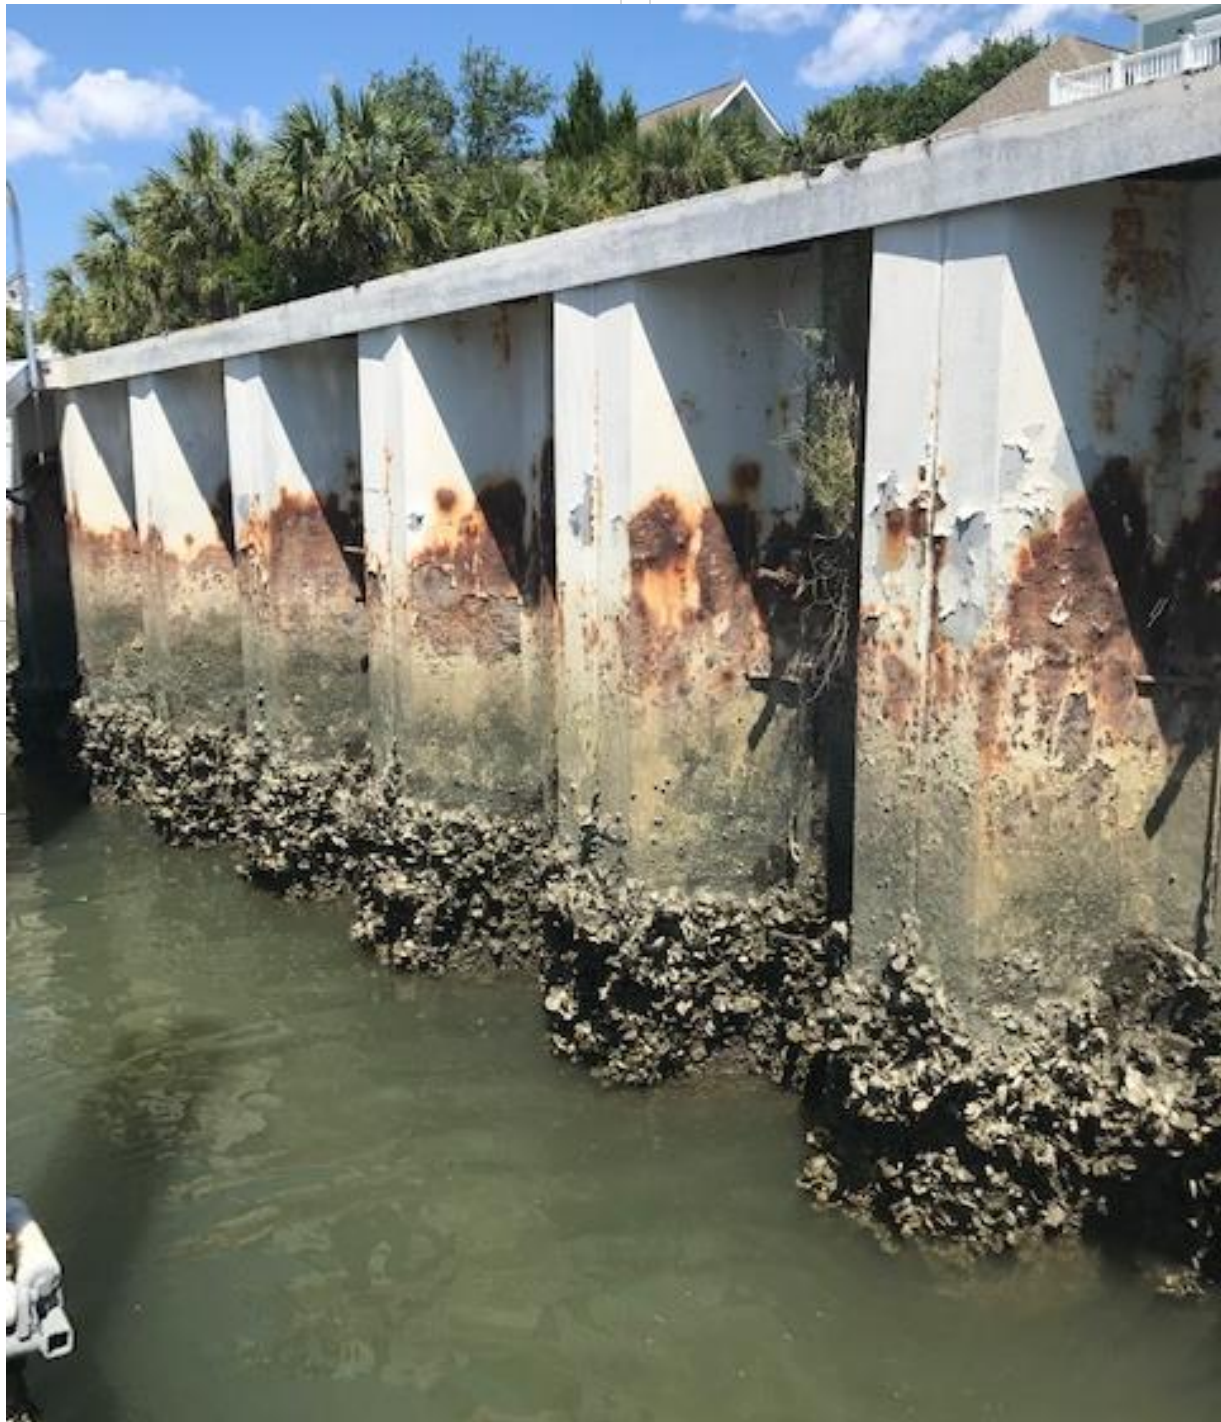
Photo 021- typical corrosion and marine build up. Note rust on anchorage assembly.

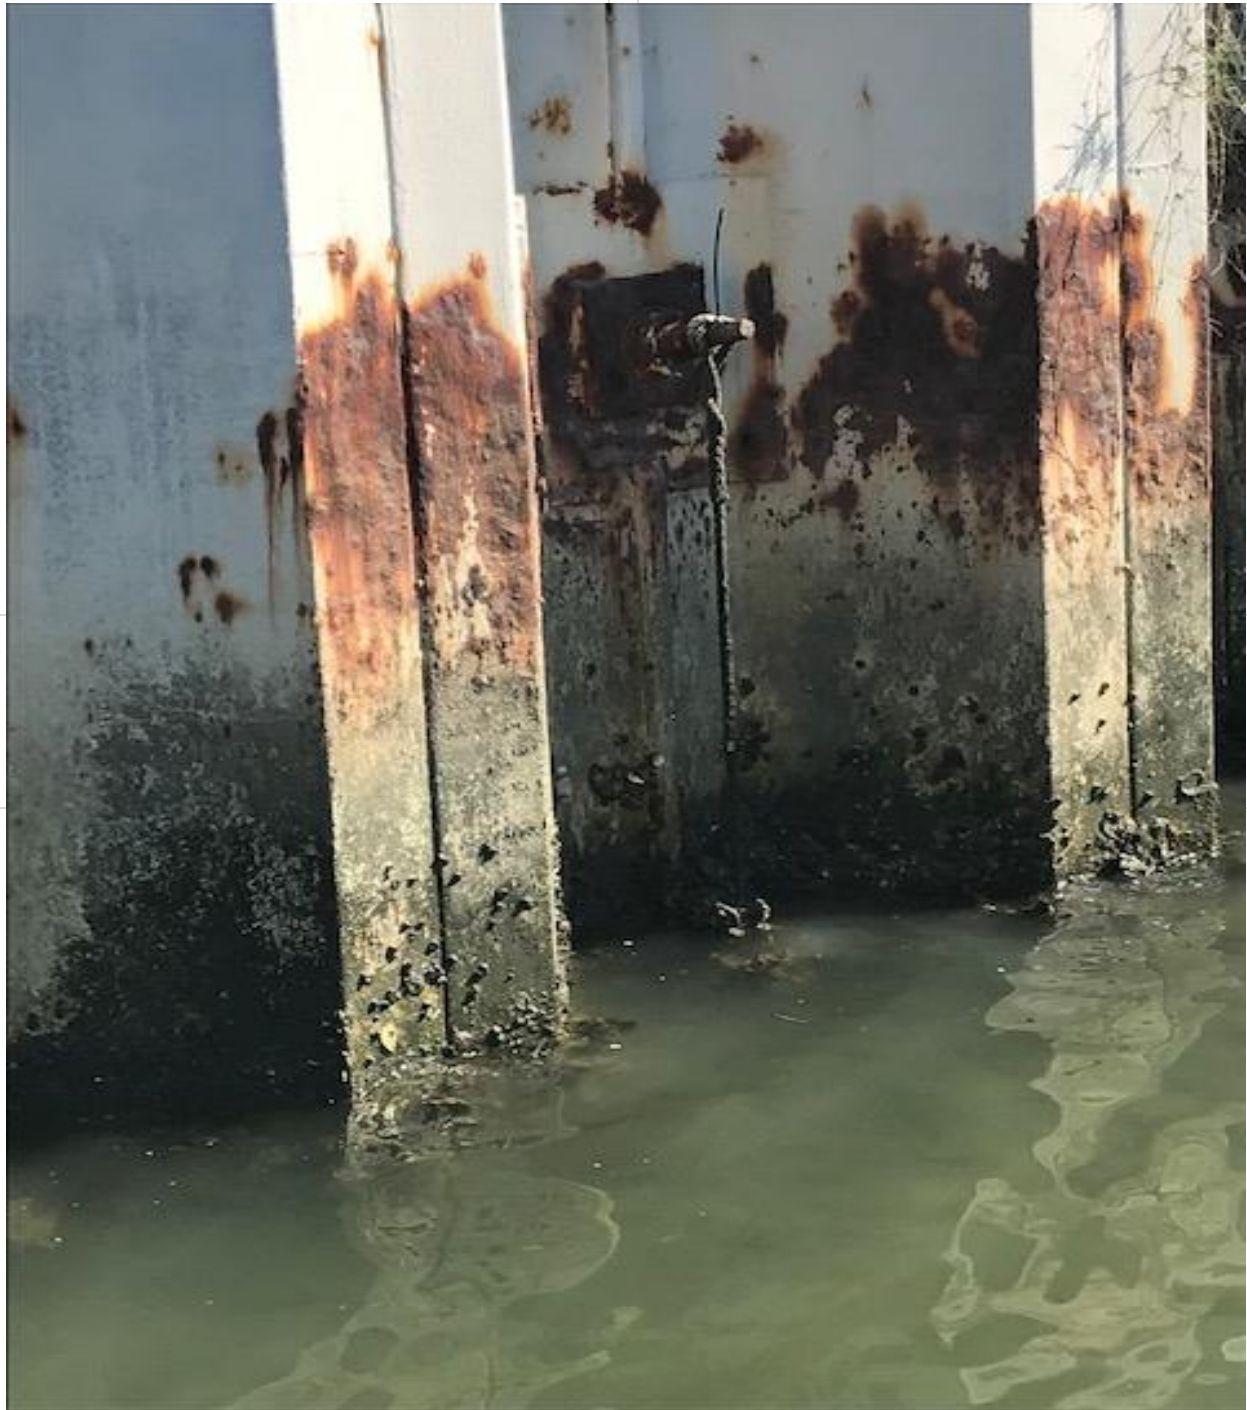
Photo 022 – corrosion on wall and anchorage assembly.
