BULKHEAD MONITORING REPORT

**Morgan Creek Harbor
Isle of Palms, South Carolina**

July 29, 2013

Terracon Project No. 73055027

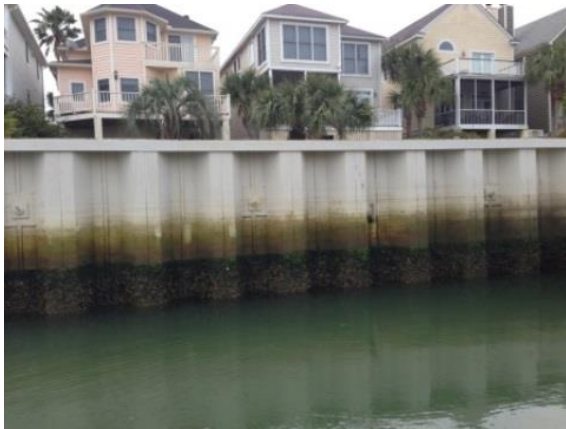
Photo #1 – Typical wall condition where pinholes have been repaired and area re-coated

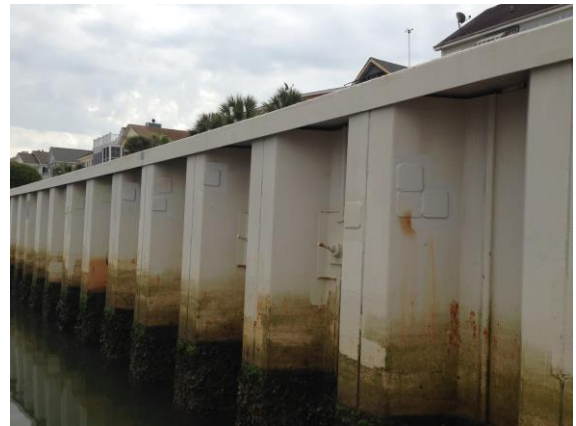
Photo #2 – Minor rust adjacent to patch plates, but overall look good

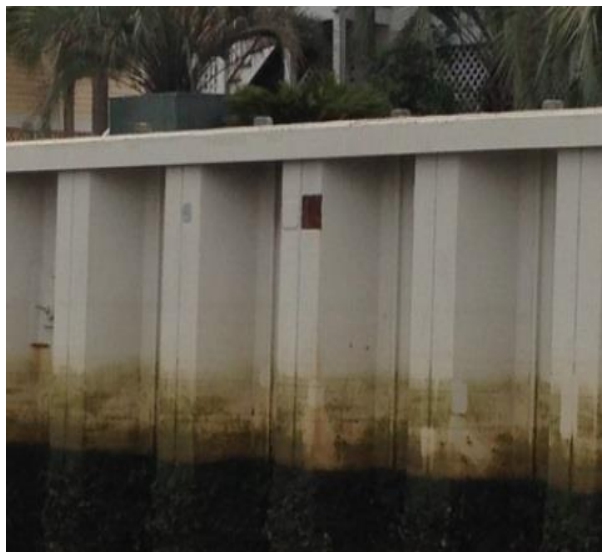
Photo #3 – Pinhole patch plate preparation (TYP). Note the patch plate has yet to be installed.

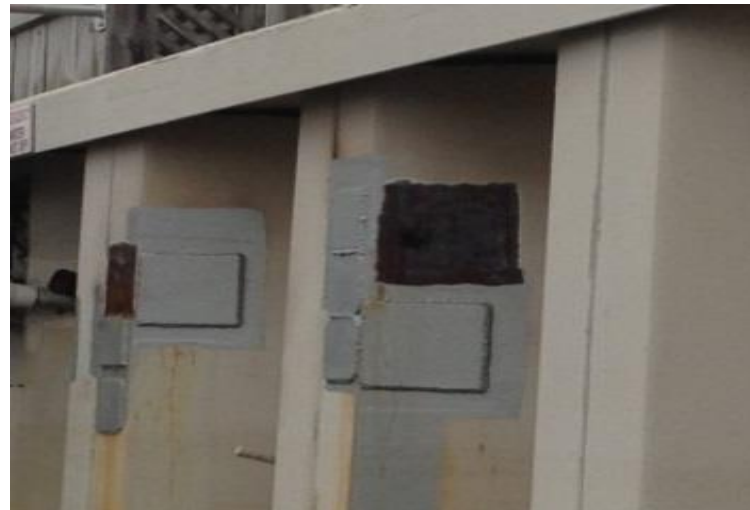
Photo #4 – Same as Photo #3. Additional pinholes adjacent to previously repaired pinholes.

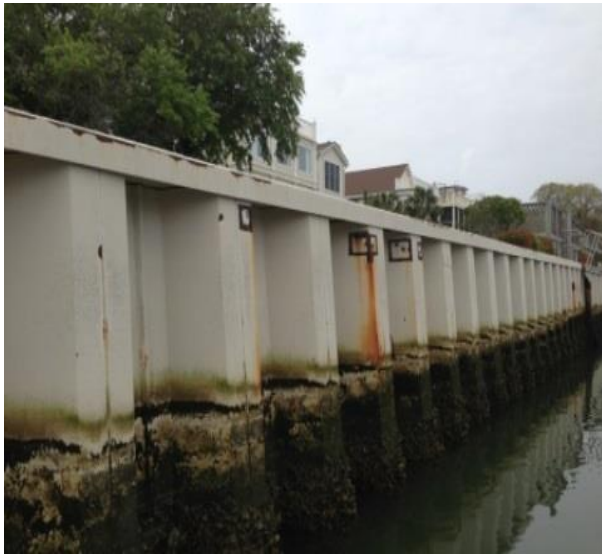
Photo #5 – Pinholes to be patched.

6. Coating of wall has been completed. Phillips Industrial began a maintenance program in the form of pinhole repairs and touch ups. The work was halted due to dredging activities. It is important that pinholes are repaired in a timely manner to minimize its impact on the wall performance. Patch plates (6"x6" and 8"x8" sheet metal plates) have been used to seal pin-holes in the past and should continue be used to repair any additional pinholes identified during maintenance program. Continual maintenance is necessary to minimize the corrosion of the bulkhead.

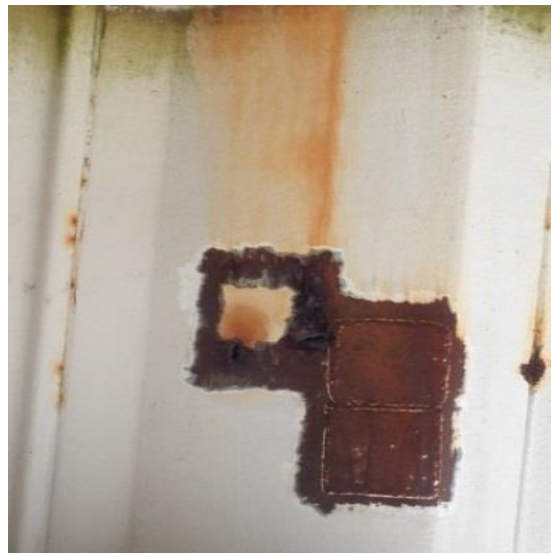
Photo #6 – Closer view of pinholes. The area has been prepared, but patch plate has yet to be placed. G-dock

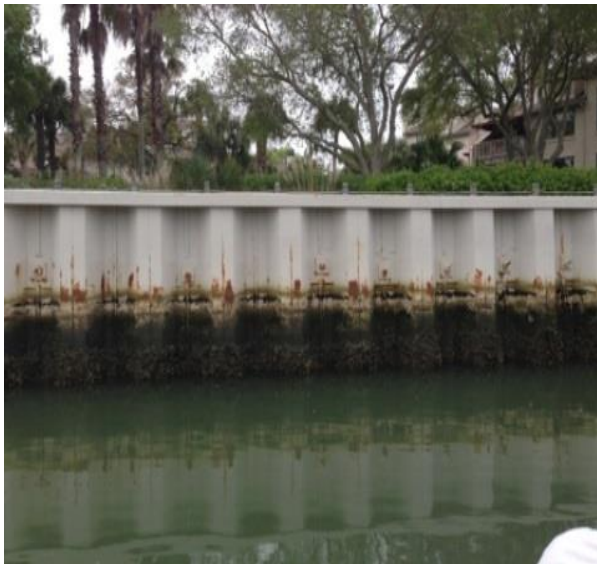
Photo #7 – Wall condition between G and H Docks. Some rust. Pinholes have formed, but have yet to be repaired.

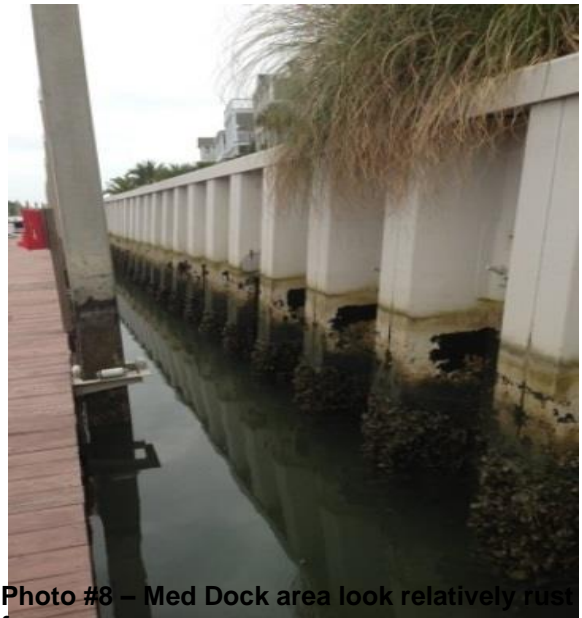
Photo #8 – Med Dock area look relatively rust free

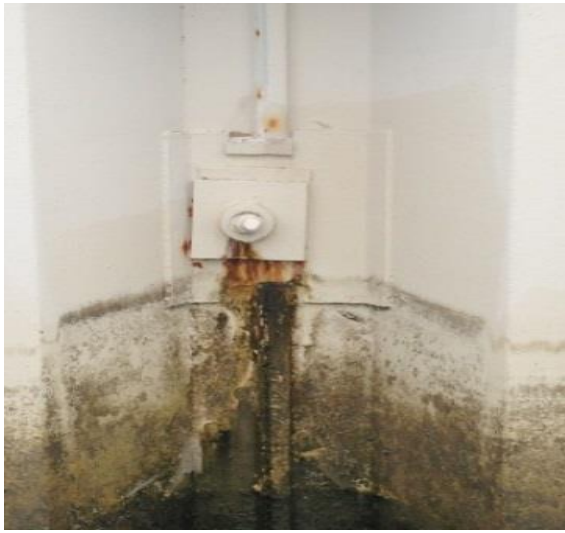
Photo #9 – leaking anchor near marker 38+39

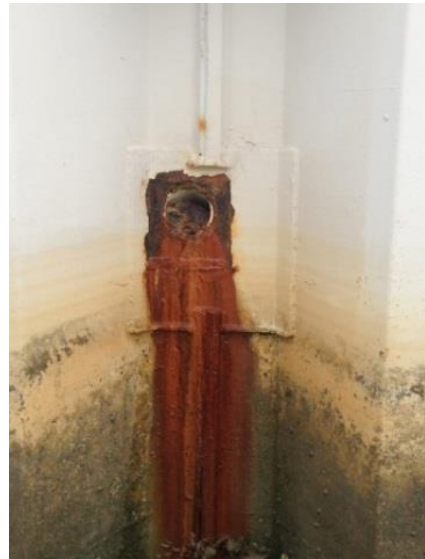
8. The tie back at 47 Water Way Island (WWI) is missing its plate and tie rod. The trumpet housing remains in contact with sheet pile, but the plate, nut and tie rod are all missing. Based on a visual observation and the measurements of adjacent markers, we did not notice any apparent distress of wall. The backfill looked good with no subsidence noted. The wall appeared to be in alignment with adjacent sections with no noticeable bulging or other form of distress. Regardless, the tie back should be repaired at the earliest time possible. Terracon will coordinate the repair with a specialty contractor.

Photo #10 – Missing anchor at 47 Water Way

Our observations were discussed with Ms. Laurie Schueler at the conclusion of field work. We informed Ms. Schueler that we would work with TIC (The Industrial Company) to prepare a repair plan for 47 WWI tie rod. TIC is familiar with bulkhead at Morgan Creek and installed the original tie rods.

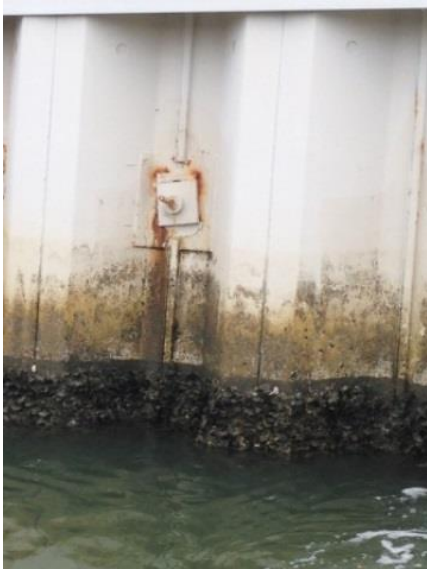
7. Tiebacks N4-184, N4-70, and N4-78, which had been repaired and backfilled previously appeared to be performing well as reported in the previous inspection reports. No water leakage and slippage were noted. Tieback N4-195, reported slipped since 2003, is essentially unchanged and the previous recommendations for repair are still applicable.

Photo #11 – Anchor slippage as reported in past inspections

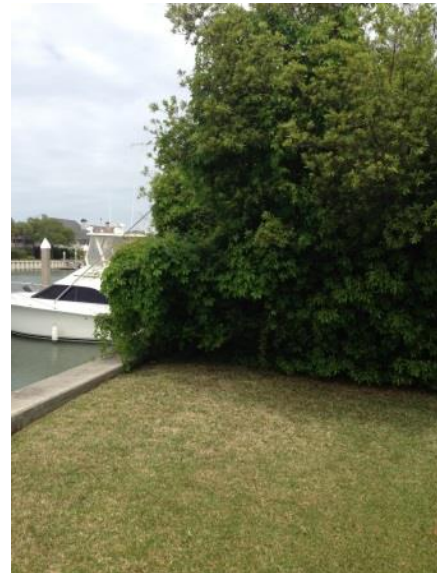
Photo #12 – overgrown shrub adjacent to the wall. Marker 44+50

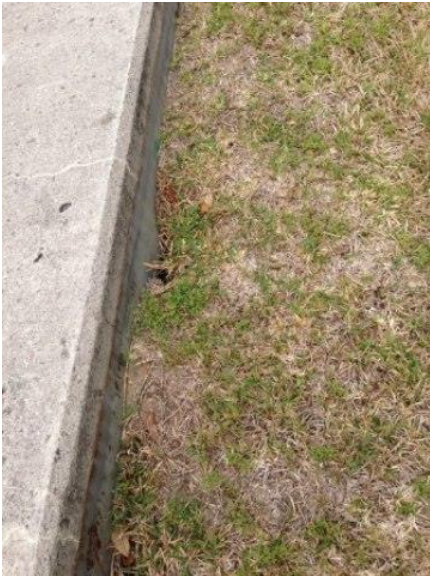
Photo #13 – Backfill subsidence near marker 48+50

4. Several areas of minor backfill subsidence were noted during our inspections. The subsidences are very minor in nature and appear to be due to the irrigation lines and/or yard inlets present in the area. These areas should be periodically inspected and filled as necessary. Consideration should also be given to locating future irrigation heads away from the bulkhead.

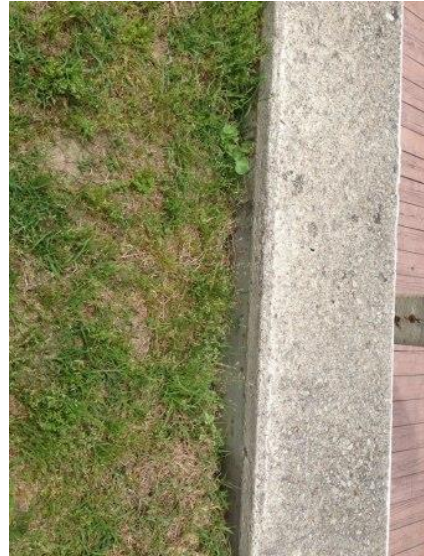
Photo #14 – Backfill subsidence near marker 43+00

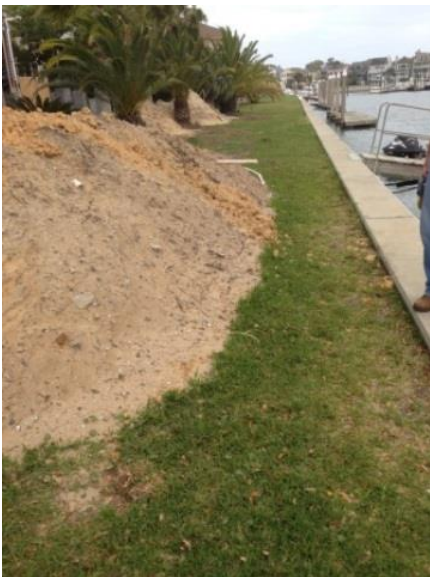
Photo #15 – Temporary soil stockpile near the wall at marker 25+50.

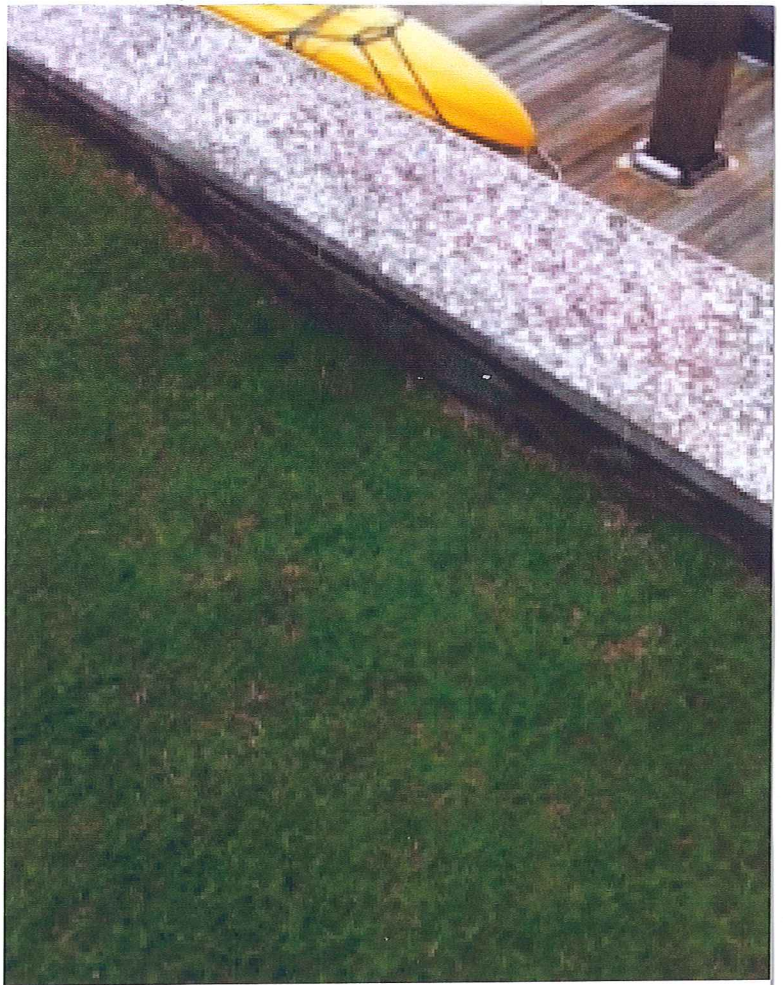
8 + 67

04+49		
	04+80		
	05+09		
	05+40		
	05+68		
	05+73		
	05+98		
	06+09		
	06+28		
	06+58		
	06+71		
	06+87		
	07+00	*Plate missing*	
	07+20		
	07+48		
	08+08		
	08+67		
	08+94	Subsidence hole, needs filling with topsoil.	Fill w/topsoil, compact.
	08+98	Slight subsidence	Fill w/topsoil, compact.
	09+29

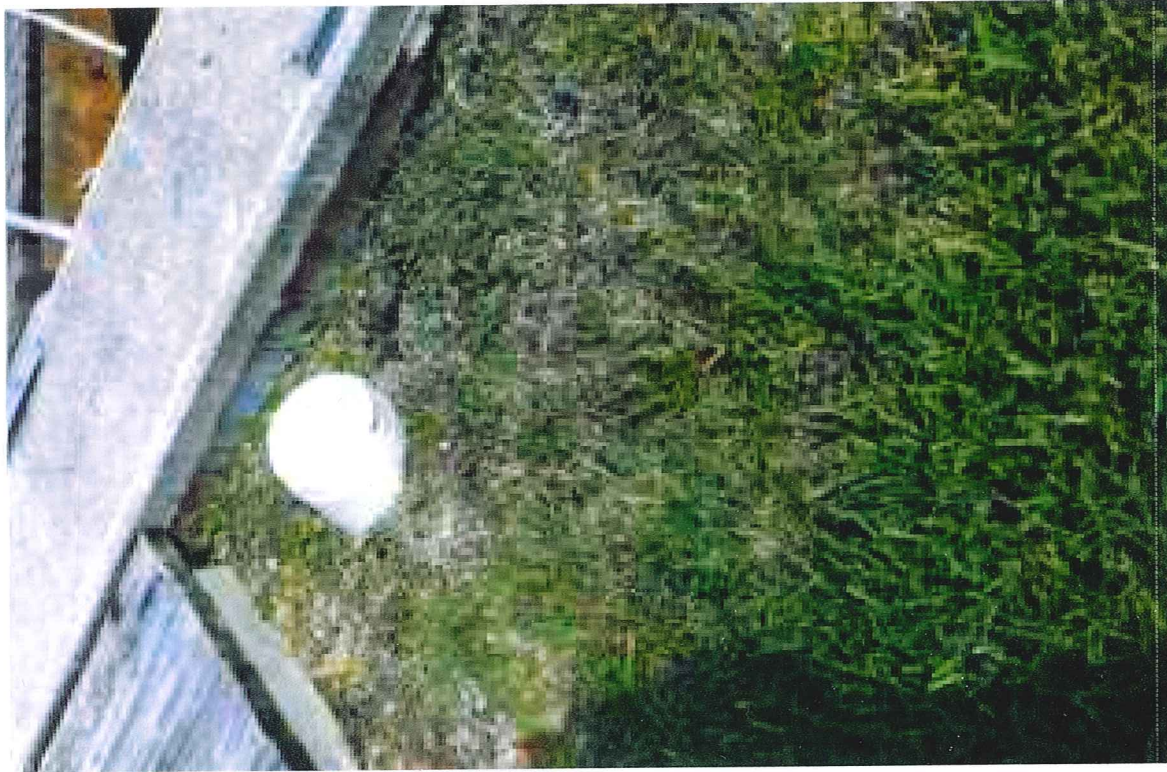
Landmark	Reference Plate	Location	Status	Notes/Recommendations
Morgan Cove Halfway House	1	60+75		
		60+42	Near halfway house. Small depression against wall.	Depression needs filling
		60+15		
Dock B Enclosure		57+00	Ramp to gangplank sunken, small trip hazard	Raise ramp to level of cap.
		56+46		
		56+35		
		56+01		
		55+78		
		55+43		
Dock C Enclosure		55+14	Ramp to gangplank sunken, small trip hazard	Raise ramp to level of cap.
		54+87		
		53+64		
		53+37		
		53+07		
		52+73		
		52+50		
		52+18		
		52+07		
		52+00	Deep subsidence hole found.	Excavate to find cause, repair problem.

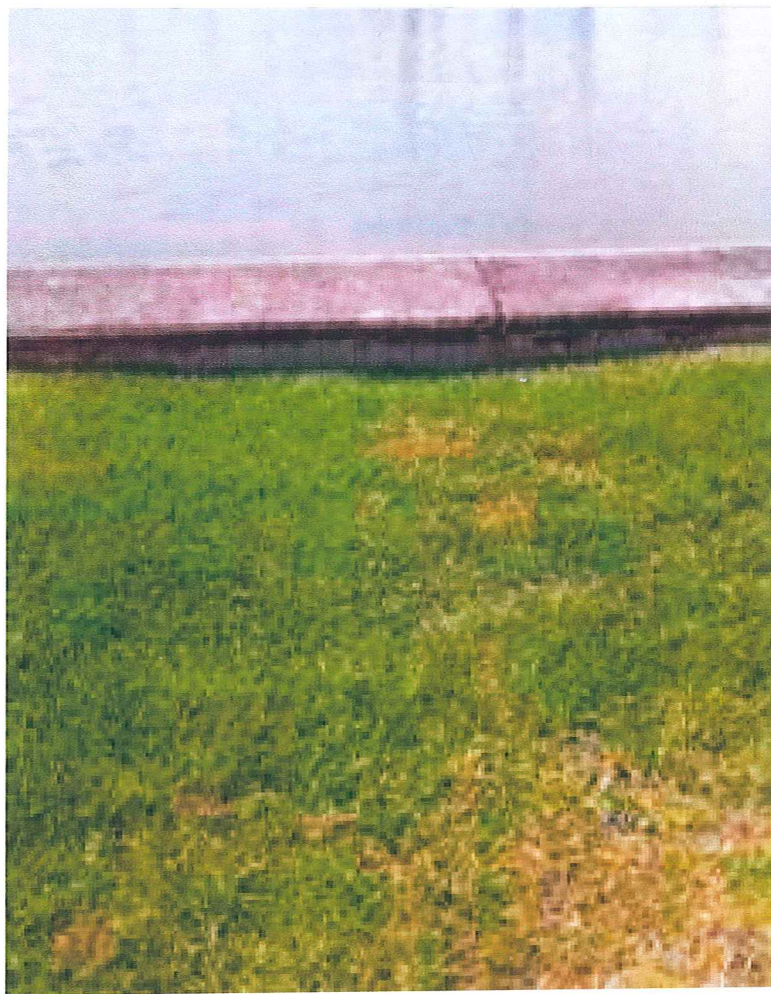
20 + 10

17+89		
		18+19		
		18+49		
		18+80		
		19+09		
		19+18		
		19+39		
		19+67		
		19+70	Medium subsidence, see pictures	Fill w/topsoil, compact.
		20+10	Large subsidence, see pictures	Fill w/topsoil, compact.
		20+96		
		21+01		
		21+21		
		21+59		
		21+94		
		22+22		
		22+27		
		22+40	Medium subsidence, see pictures	Fill w/topsoil, compact.

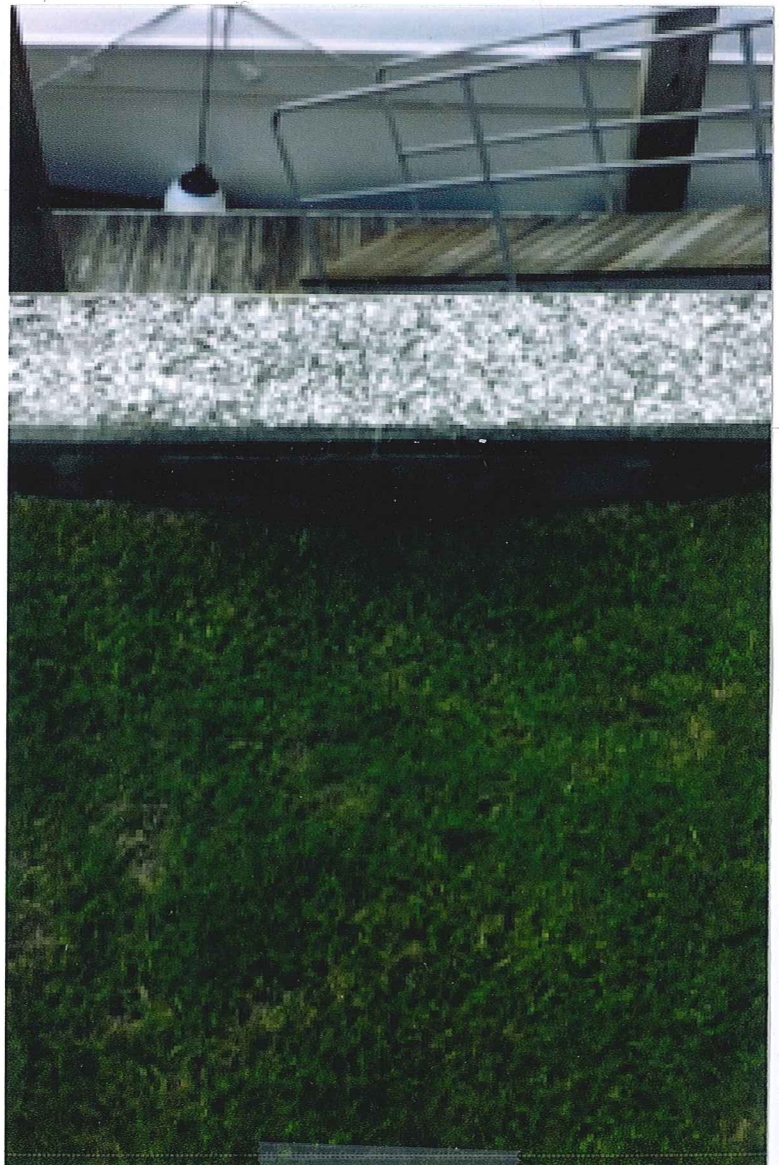
14 + 90

09+58		
	09+98	Slight subsidence	fill w/topsoil, compact.
	10+48		
	10+80		
	11+05		
	11+35		
	11+54		
	11+95		
	12+24		
	12+54		
	12+84		
	13+20	Slight subsidence	Fill w/topsoil, compact.
	14+52		
	14+90	Medium subsidence, see pictures	Fill w/topsoil, compact.
	15+21		
	15+98	Medium subsidence, see pictures	Fill w/topsoil, compact.
	16+68		
	16+99		
	17+30		
	17+59
