# Bulkhead Anchor Conditions Evaluation

# Morgan Creek Harbor Association Isle of Palms, South Carolina

December 12, 2019 Terracon Project No. 73055027

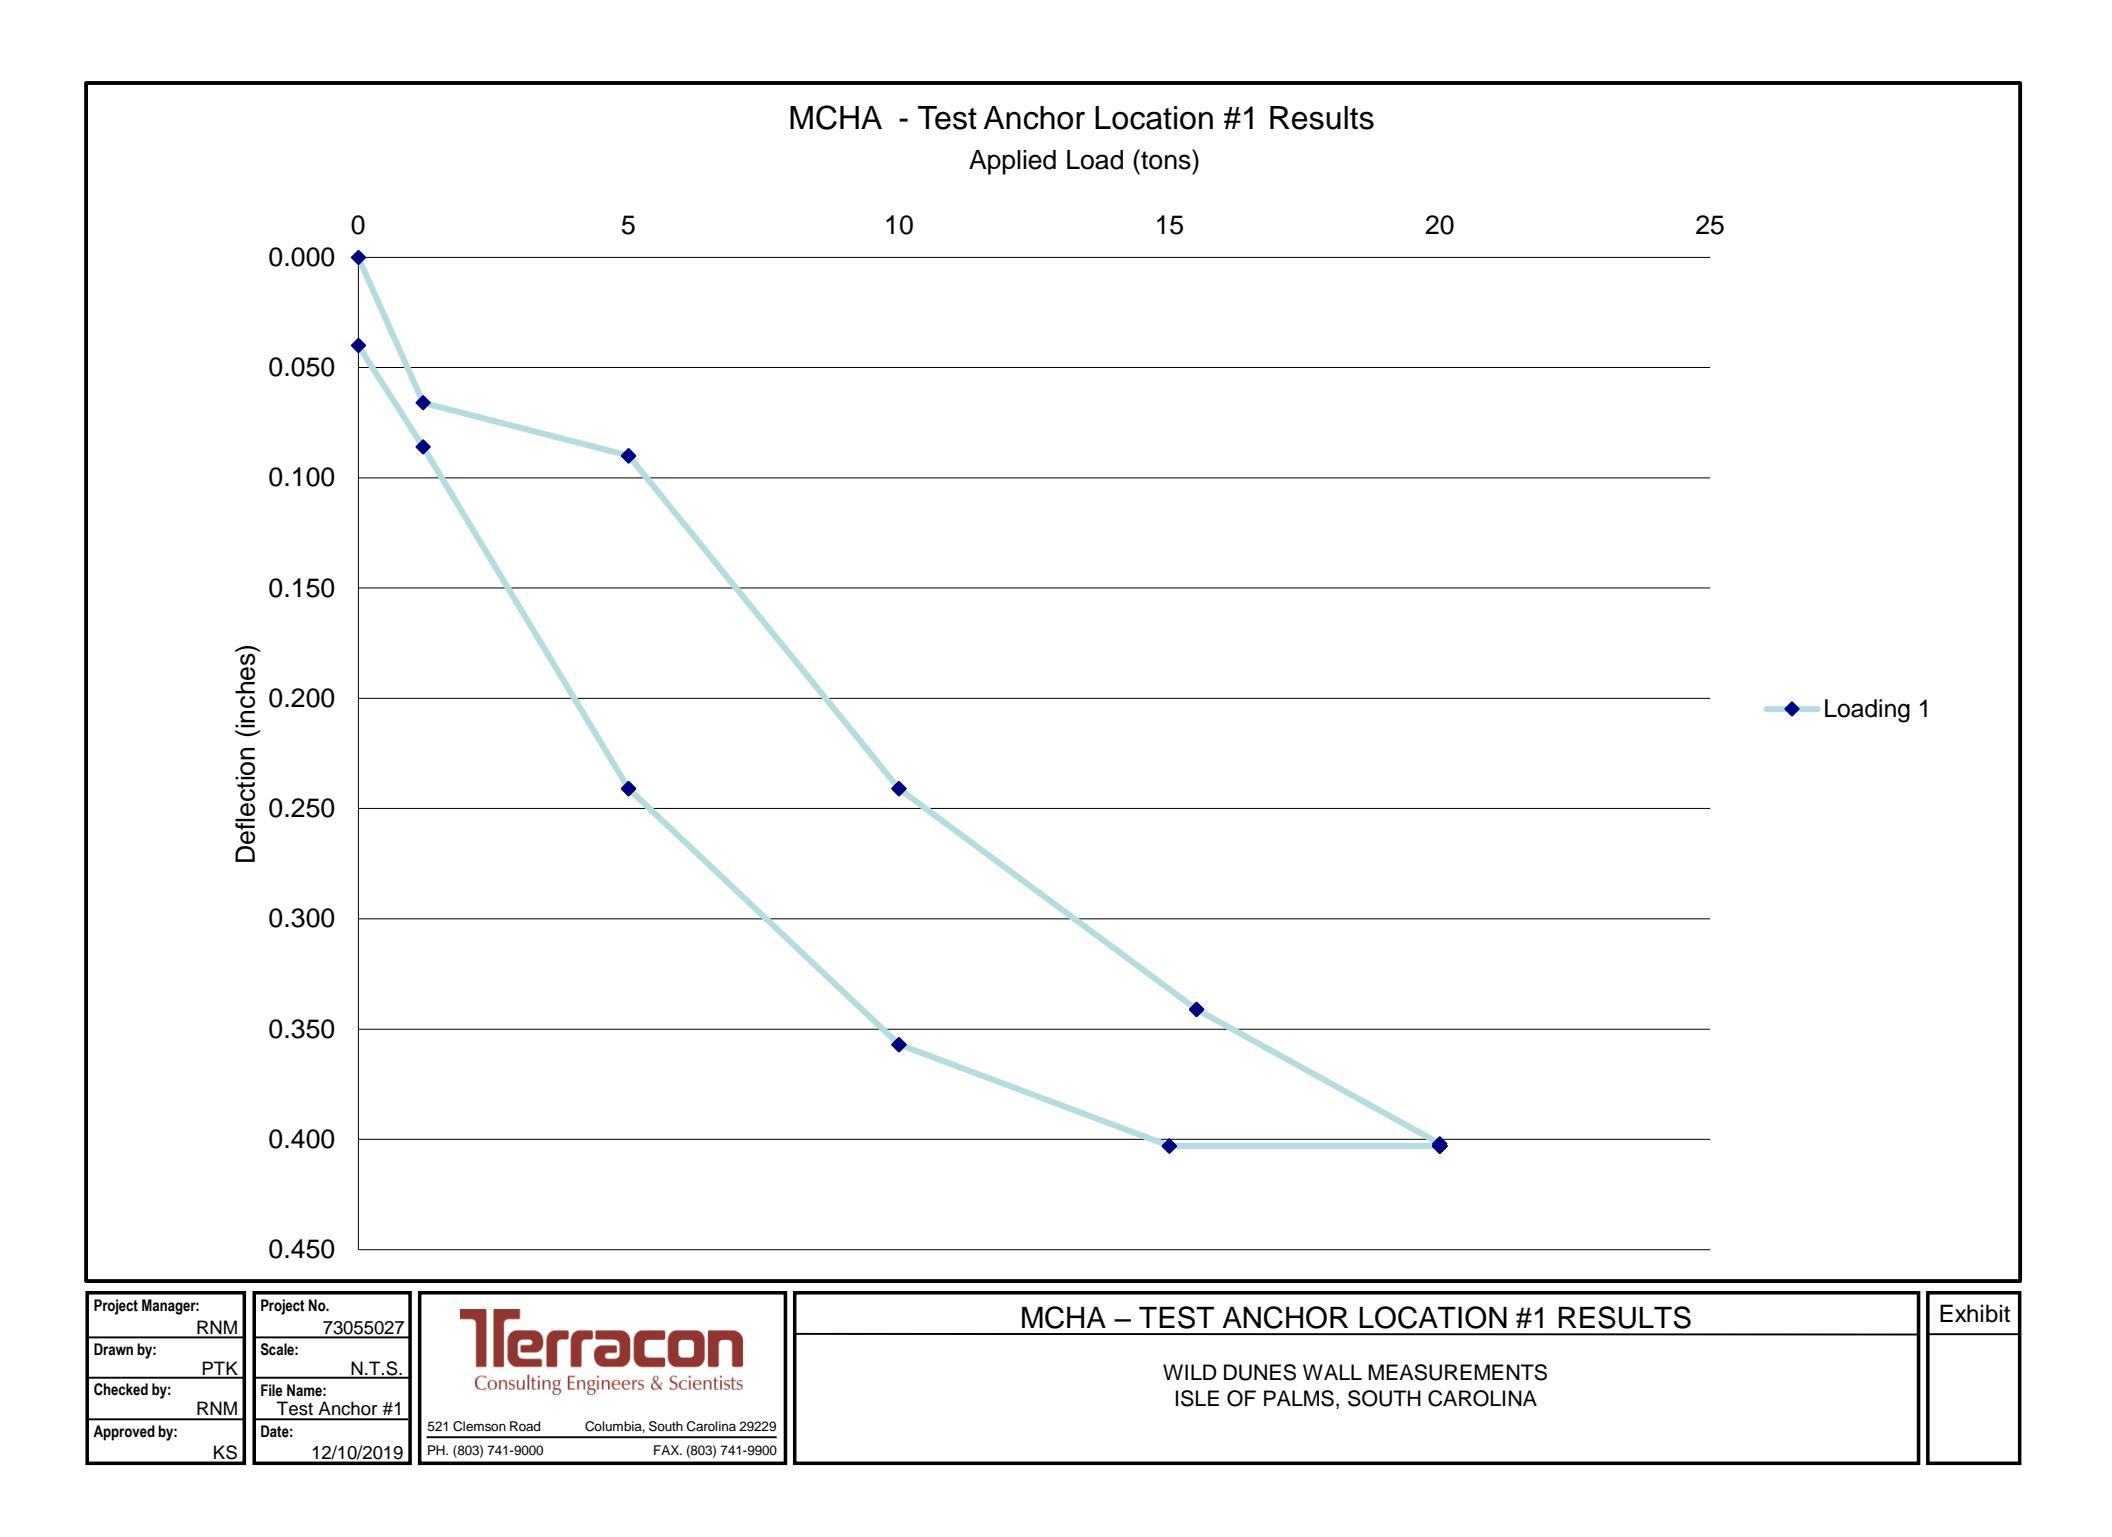
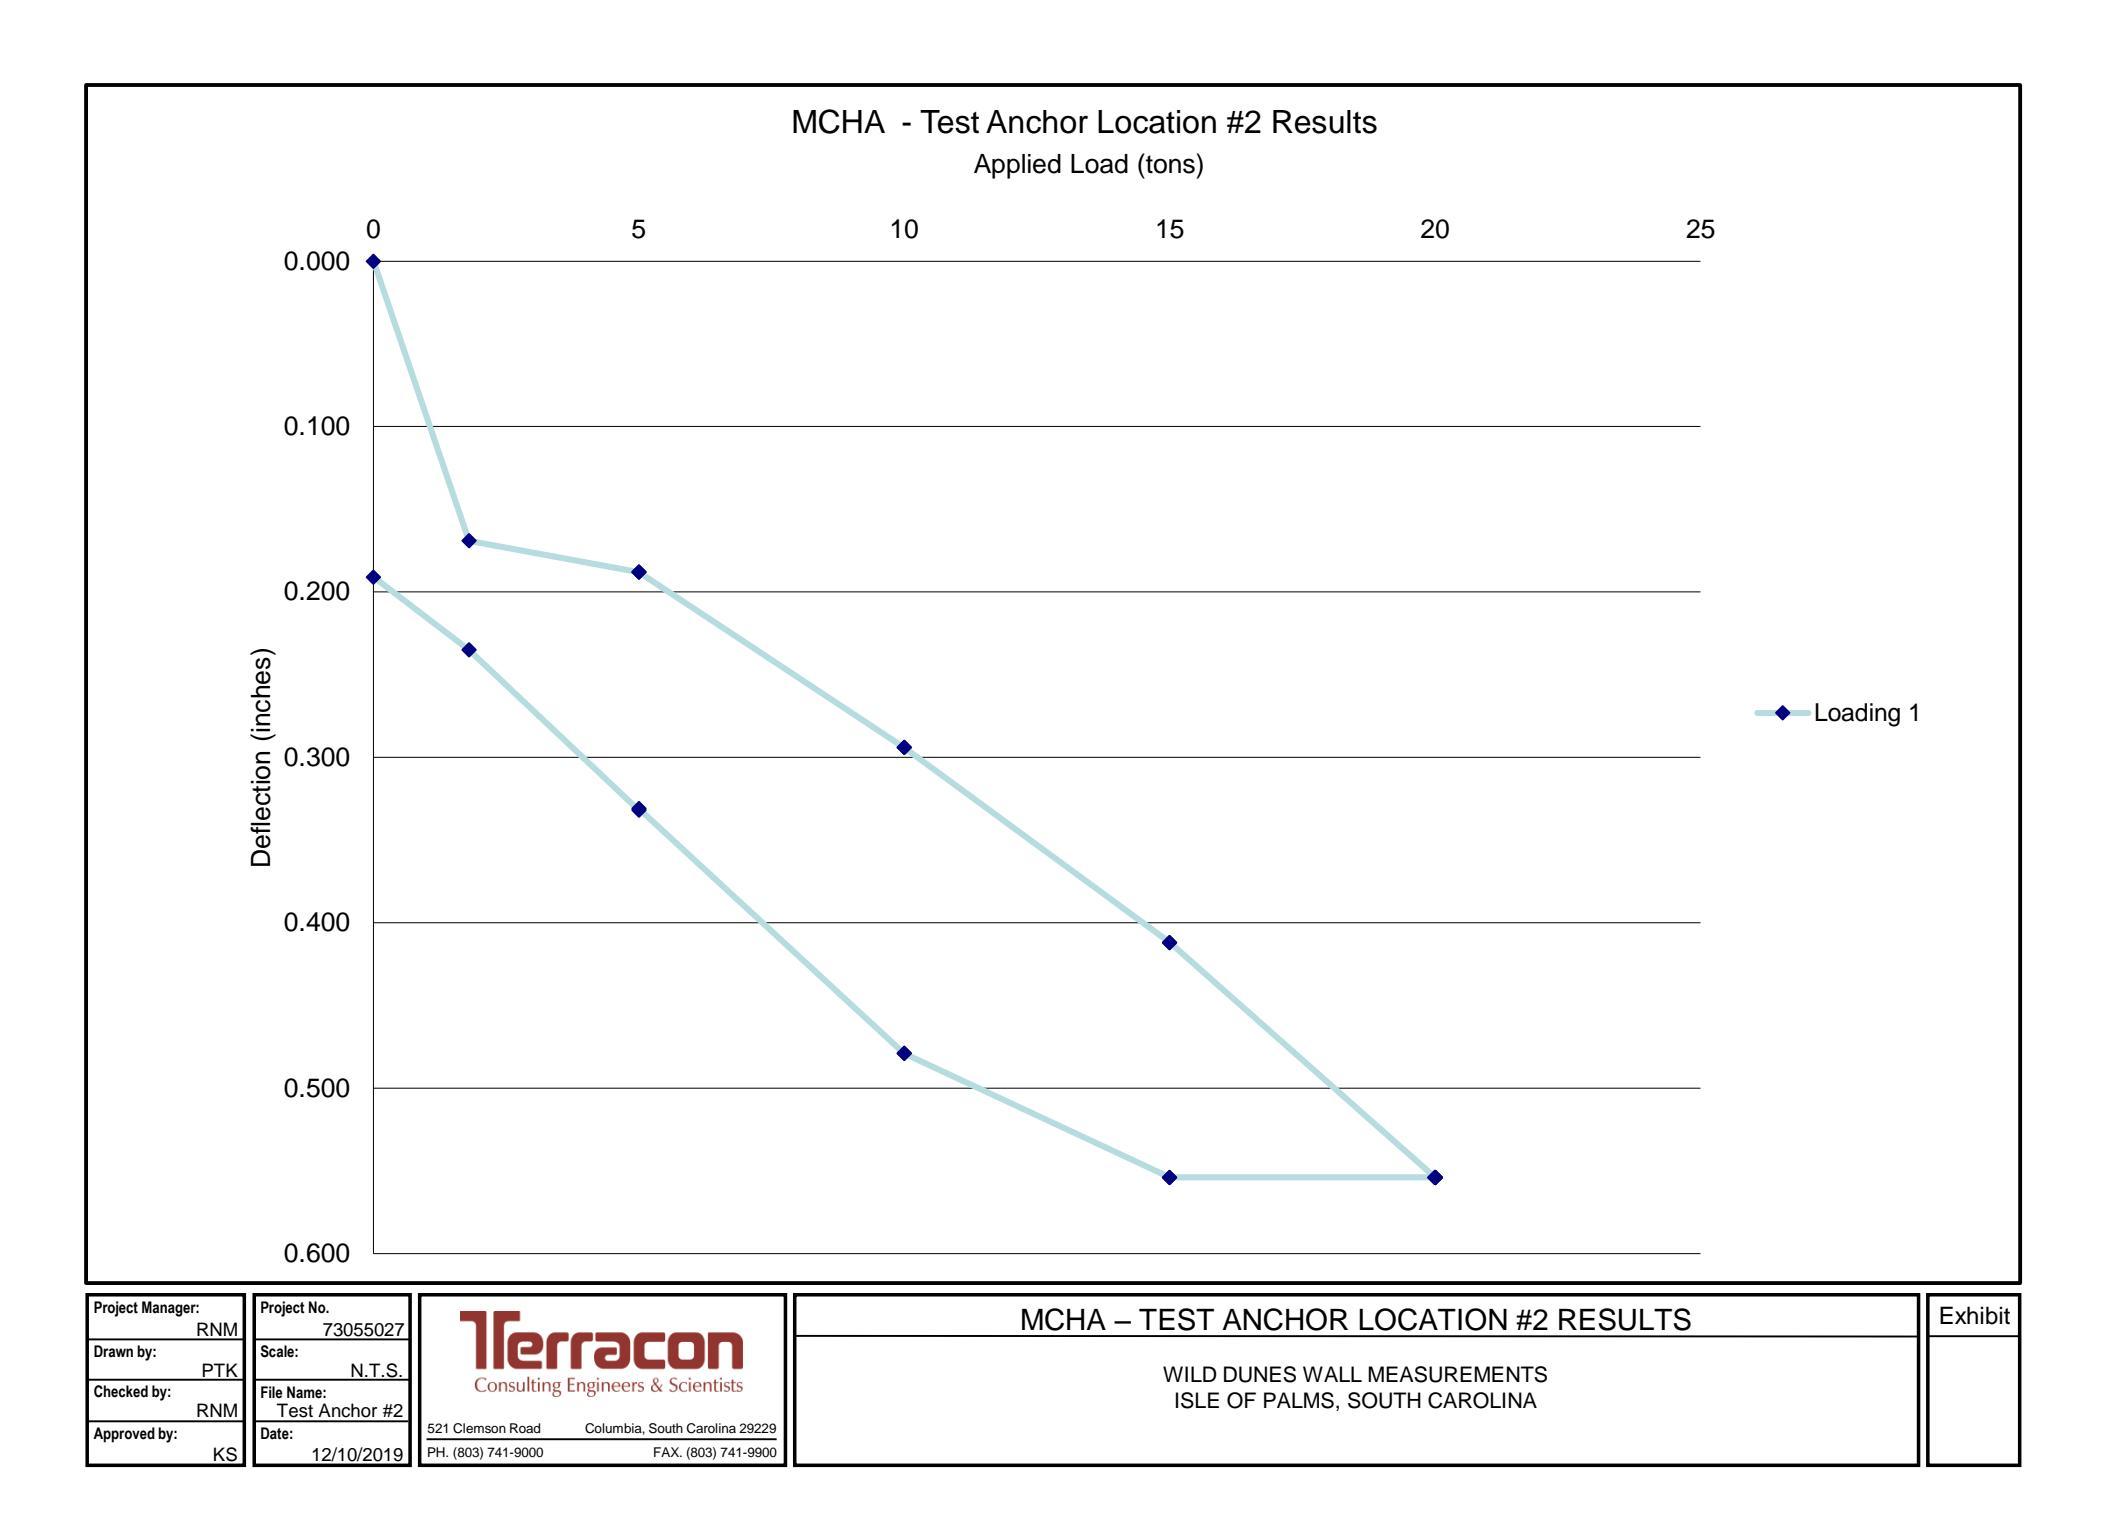
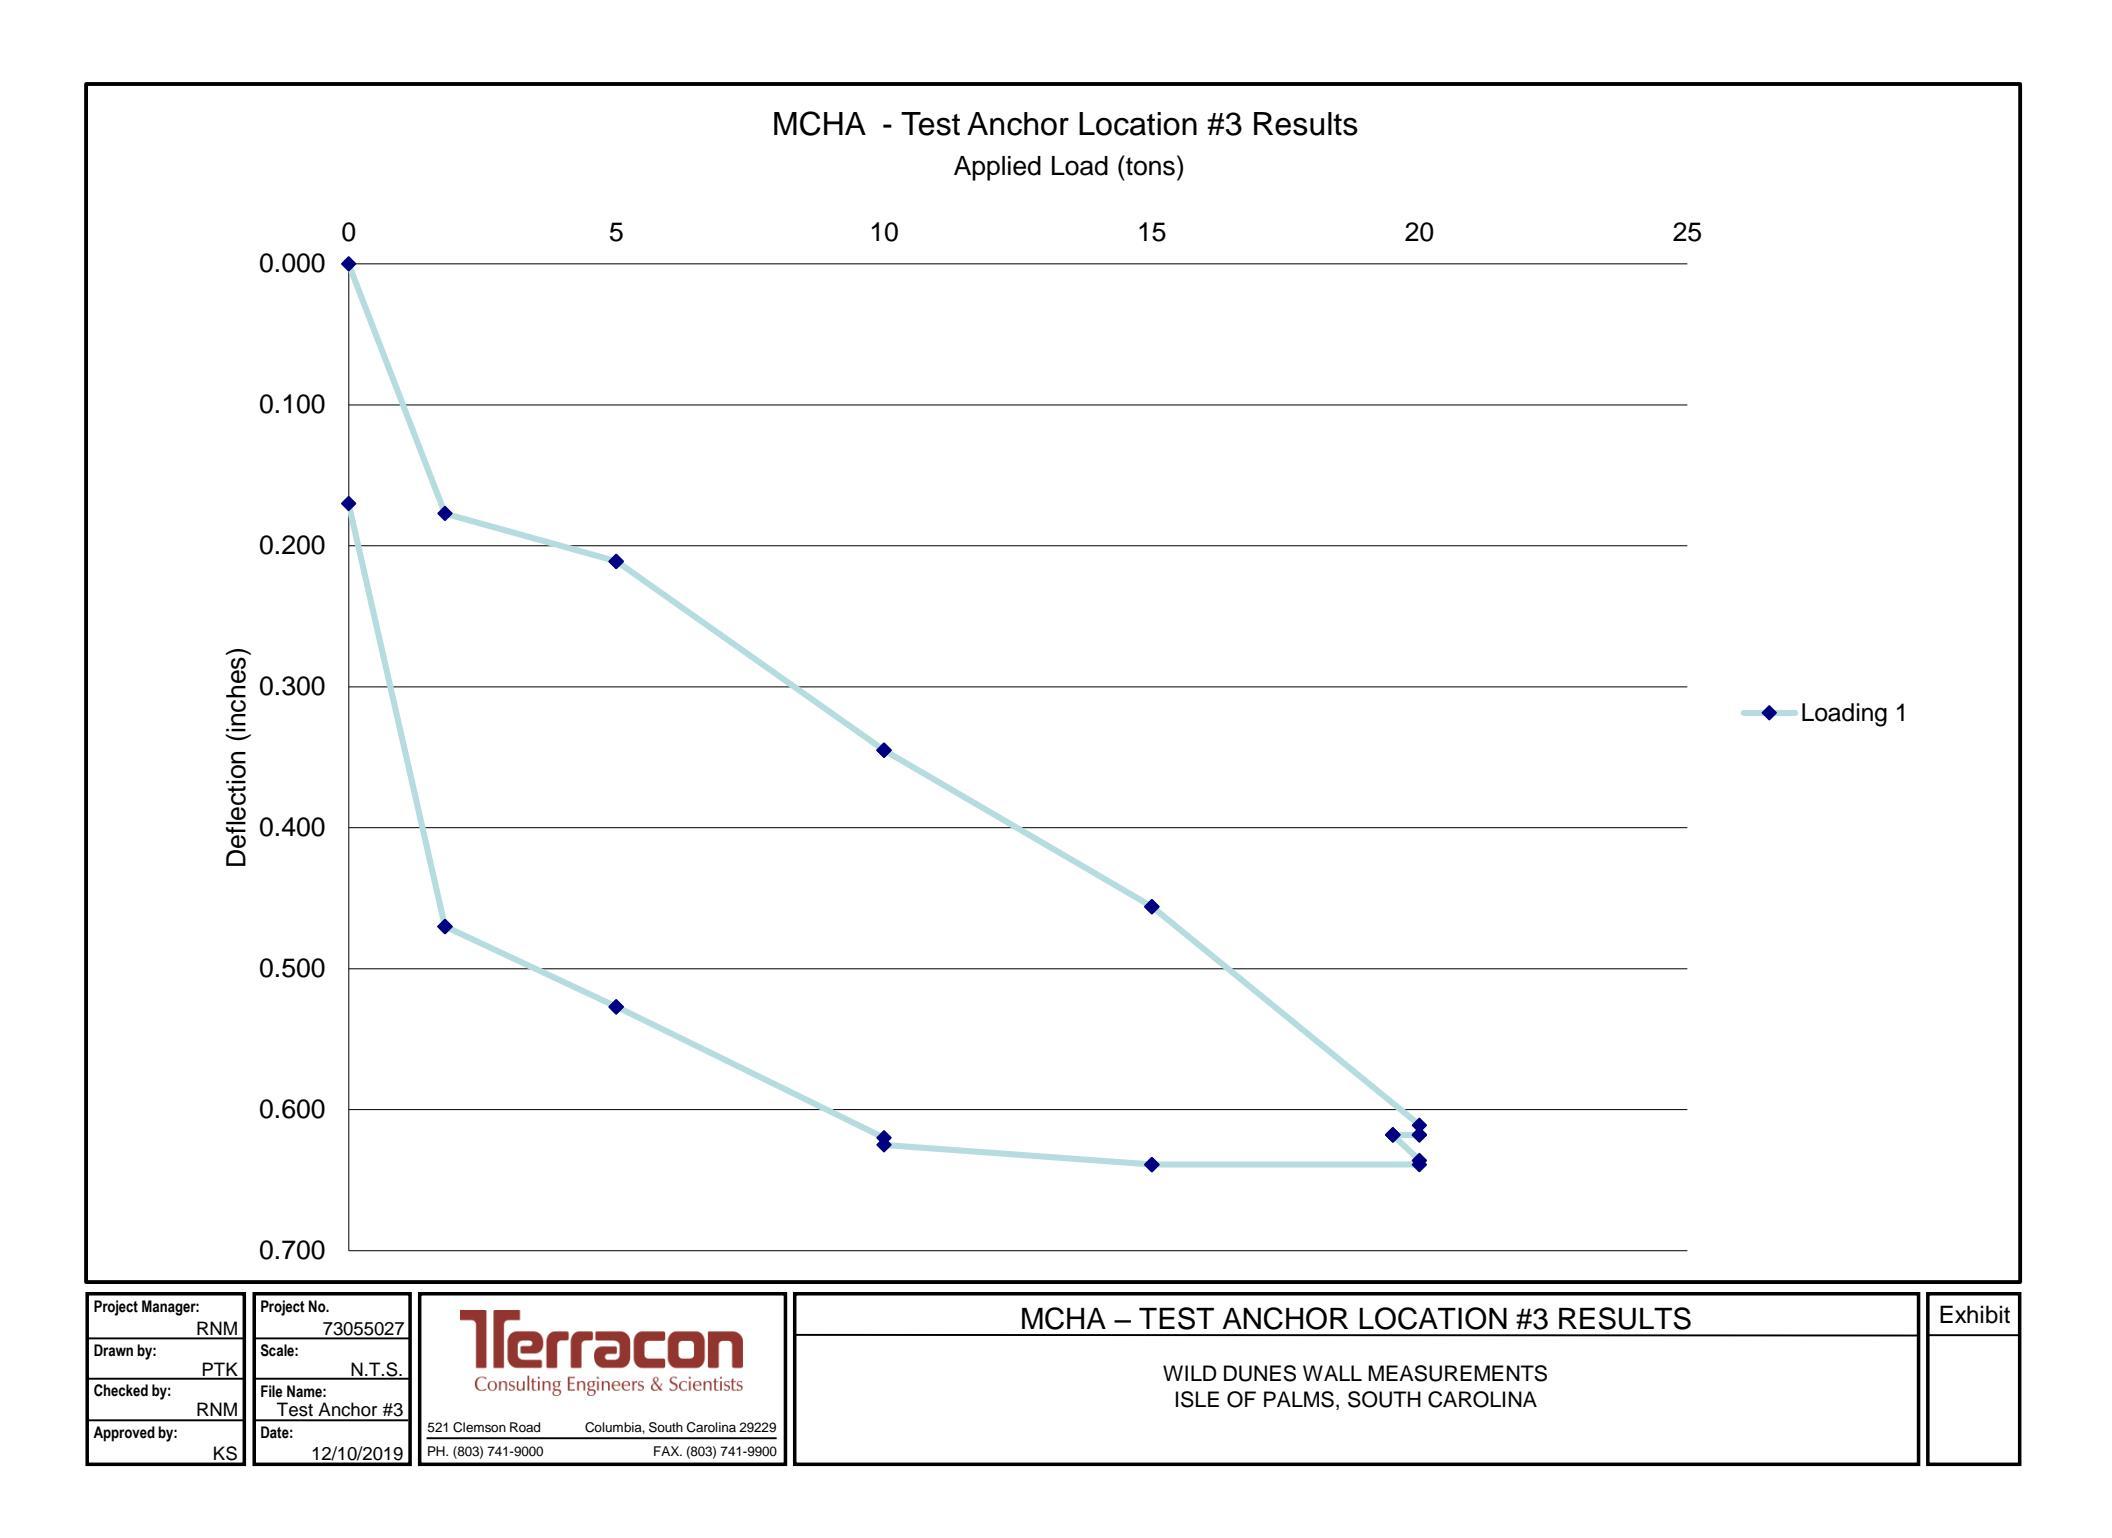
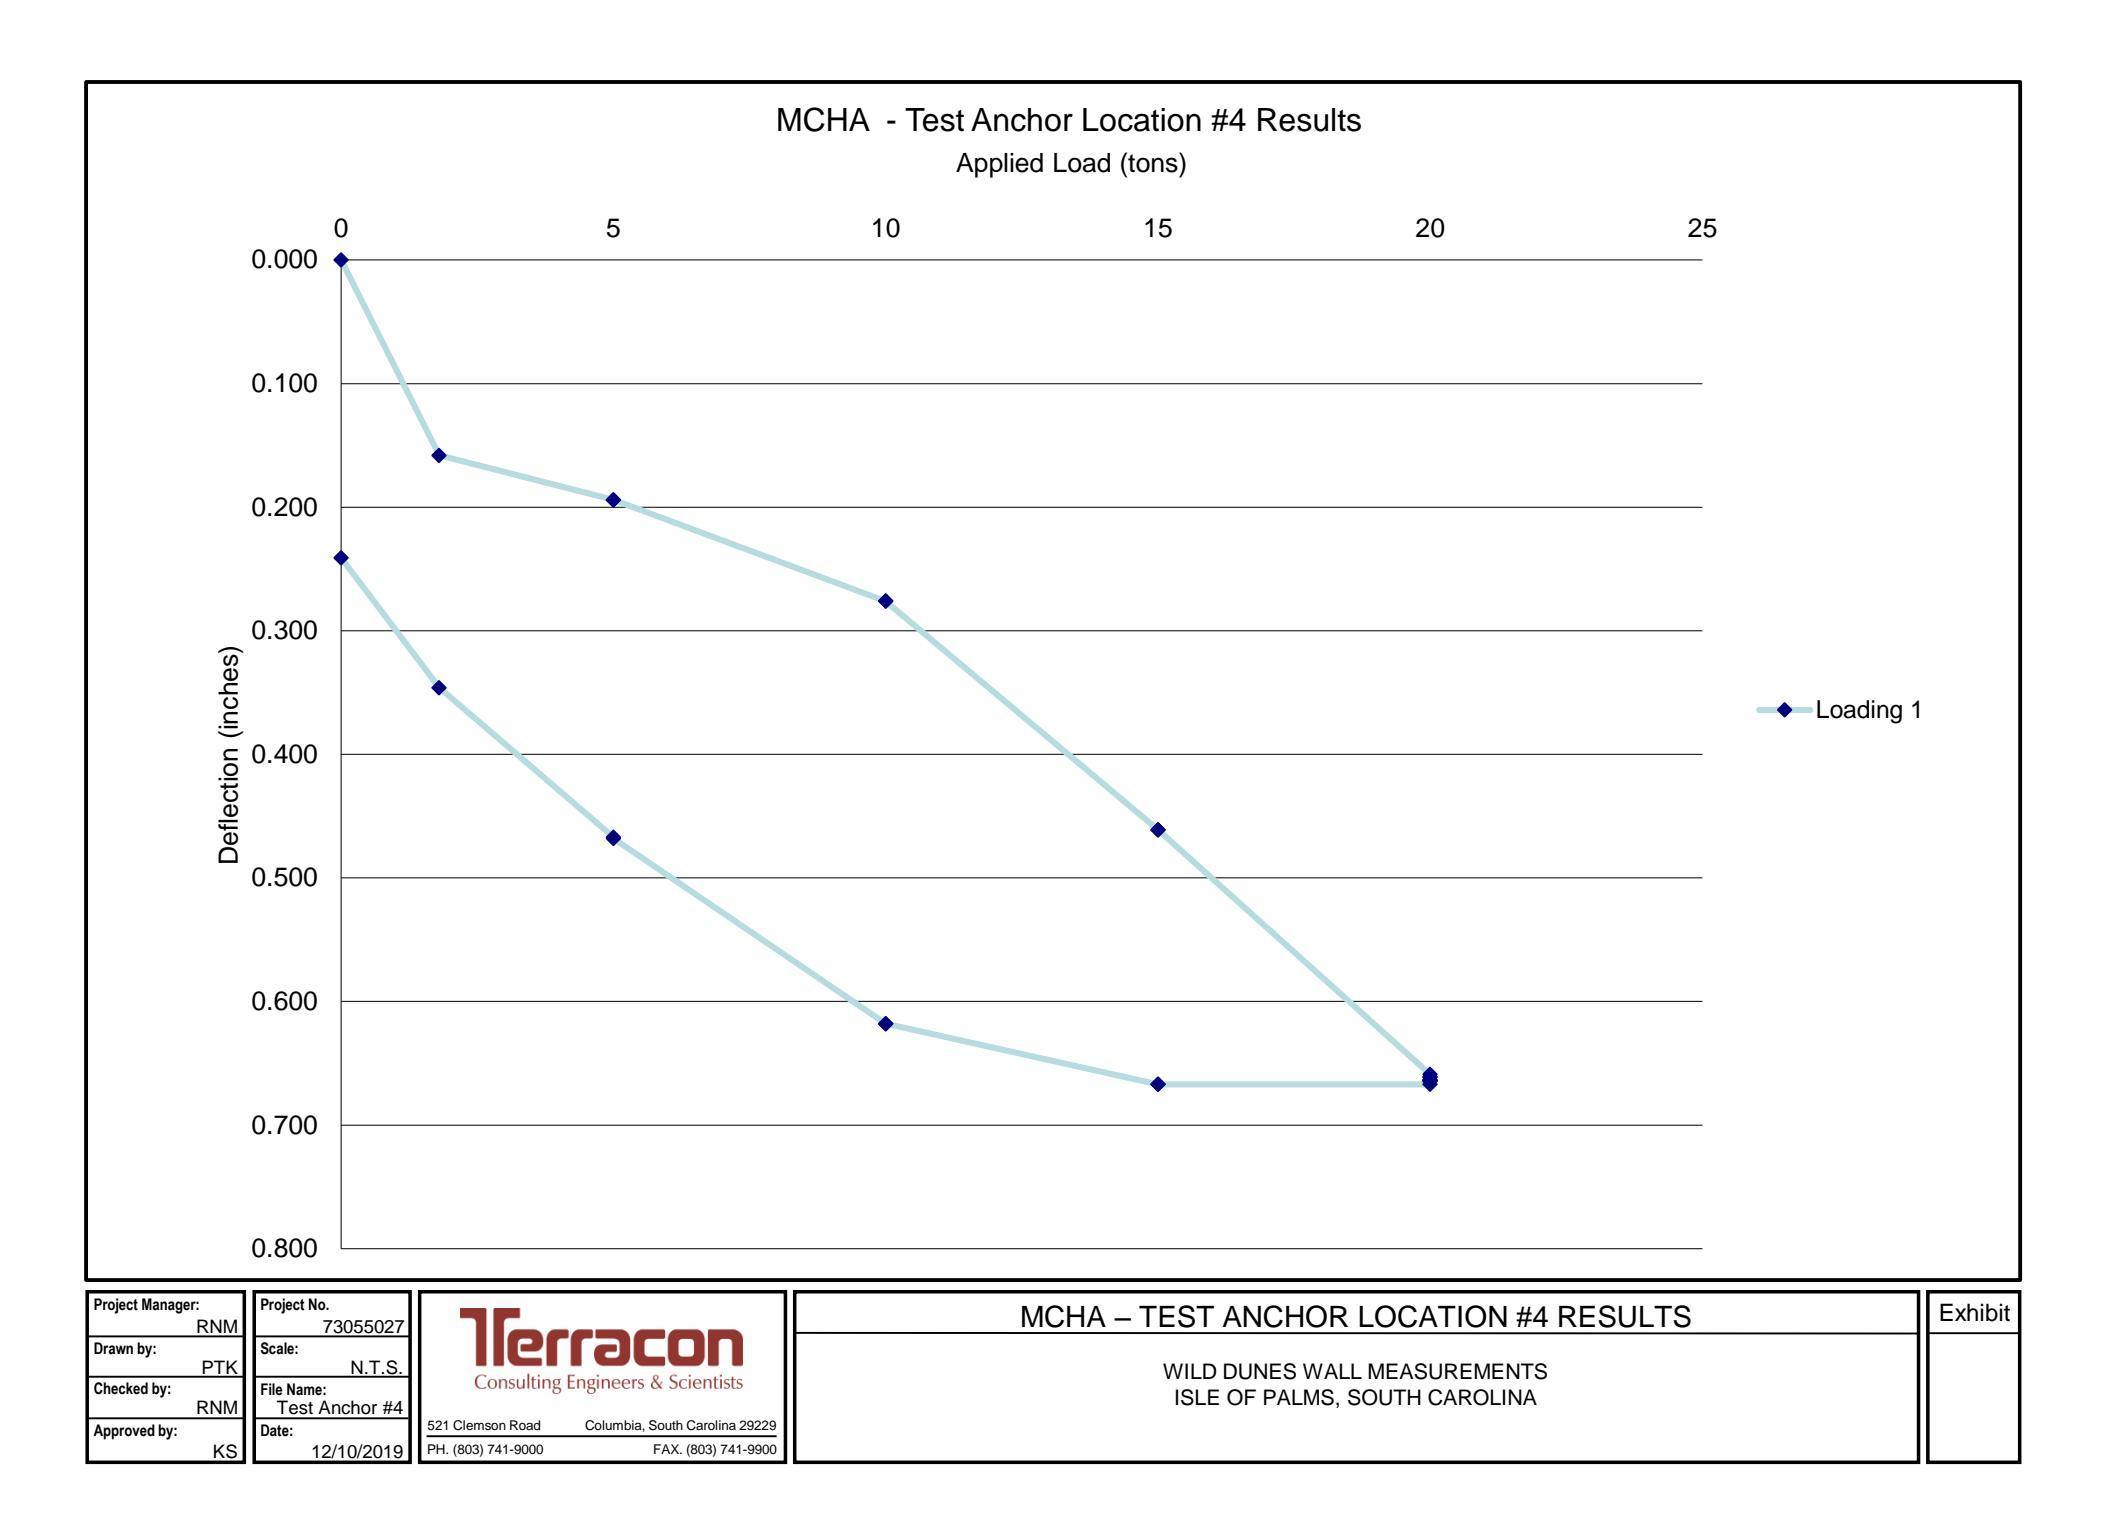
Data obtained during the load test are shown graphically in Figures A, B, C, and D in the Appendix. The loads shown were measured at the steel fitting on the free end of the anchor rod, based on the contractor's ram and pump. At the proof load (20 tons), the recorded deflection was about 1/2 inch for each anchor. Once the proof load was removed, the permanent deflection at the steel fitting was about 0.2 inches for Anchors at locations #2, #3, and #4; for Anchor #1, the permanent deflection was less than 0.1 inches.

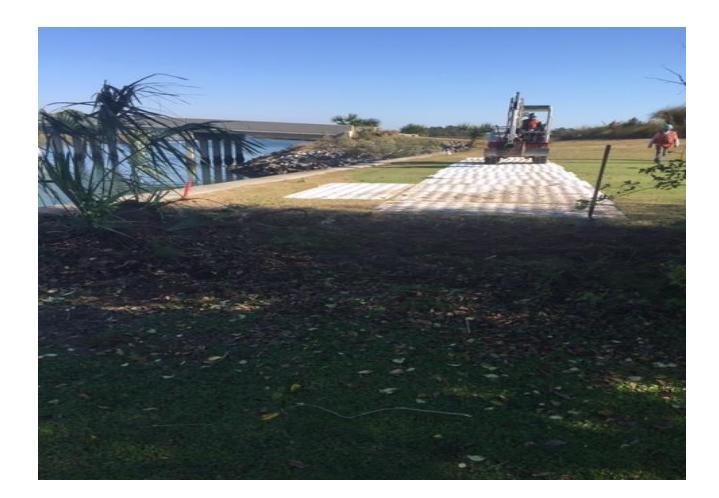
Photo #4 Location #2, station 28+00 . Access to test location with mini-excavator

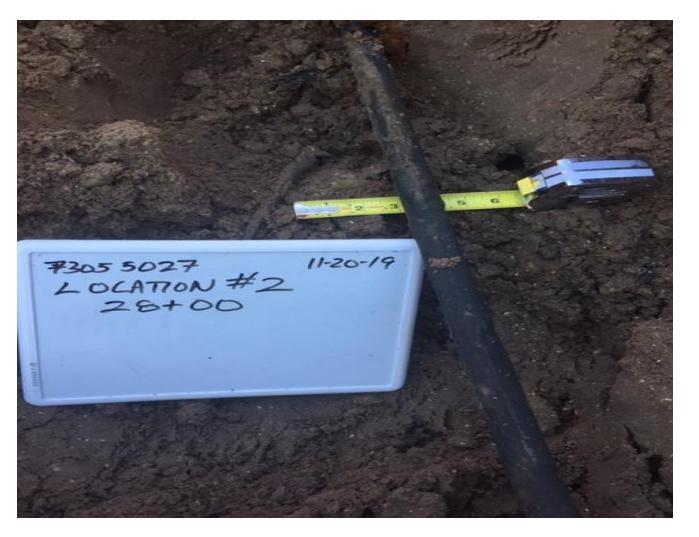
Test Location	Tie Rod Diameter (inches)	Remarks
#1 / 59+80	1.00	Black grease coating on tie rod; rectangular plate nominal ½ x 3 inches partially exposed & welded to tie rod. Photos 1,2,3
#2 / 28+00	1.11	Black grease coating on tie rod. Photos 4, 5
# 3 / 3+58	1.17	Black plastic coating on tie rod. Photos 6,7,8
#4 / 21+58	1.17	Black plastic coating on tie rod; rectangular plate nominal <sup>1</sup> / <sub>2</sub> x 4 inches partially exposed & welded to tie rod. Photos 9,10,11

#### Photo #5 rod

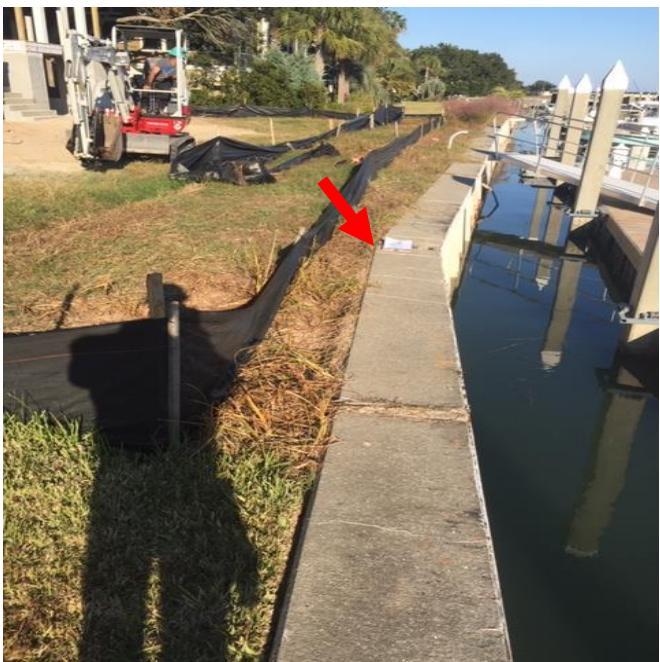
**Photo #6** Location #3, prior to excavation. Notebook on wall is station 3+50, mini-excavator at upper left in photo.

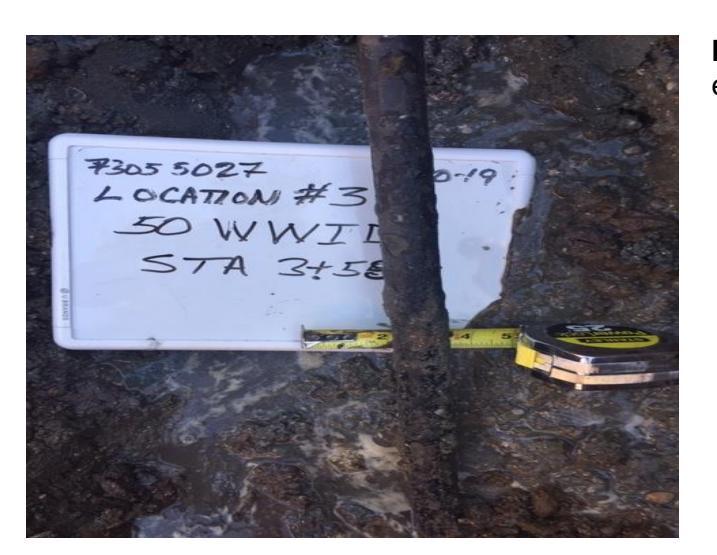
Photo #7 exposed. Location #3, tie rod

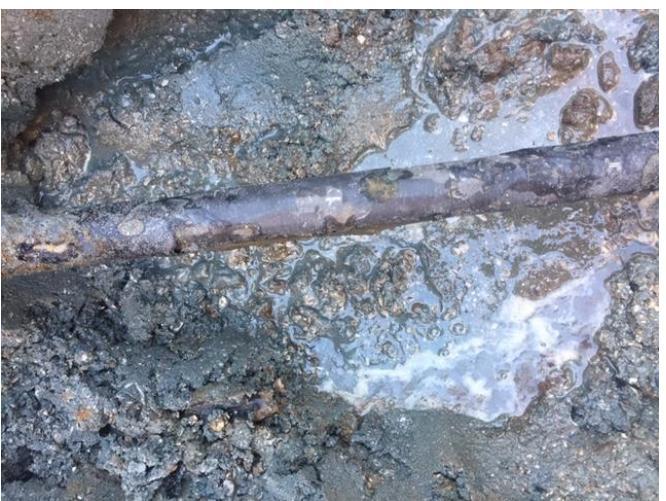
**Photo #8** Location #3, tie rod exposed. Plastic/polymer coating visible. Water seeping into excavation at time of photo.

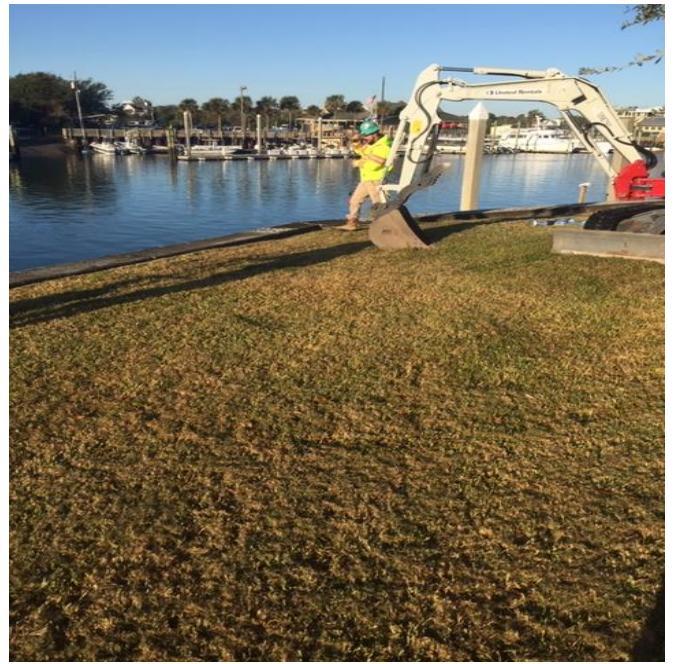
**Photo #9** 21+58

Location #4, station

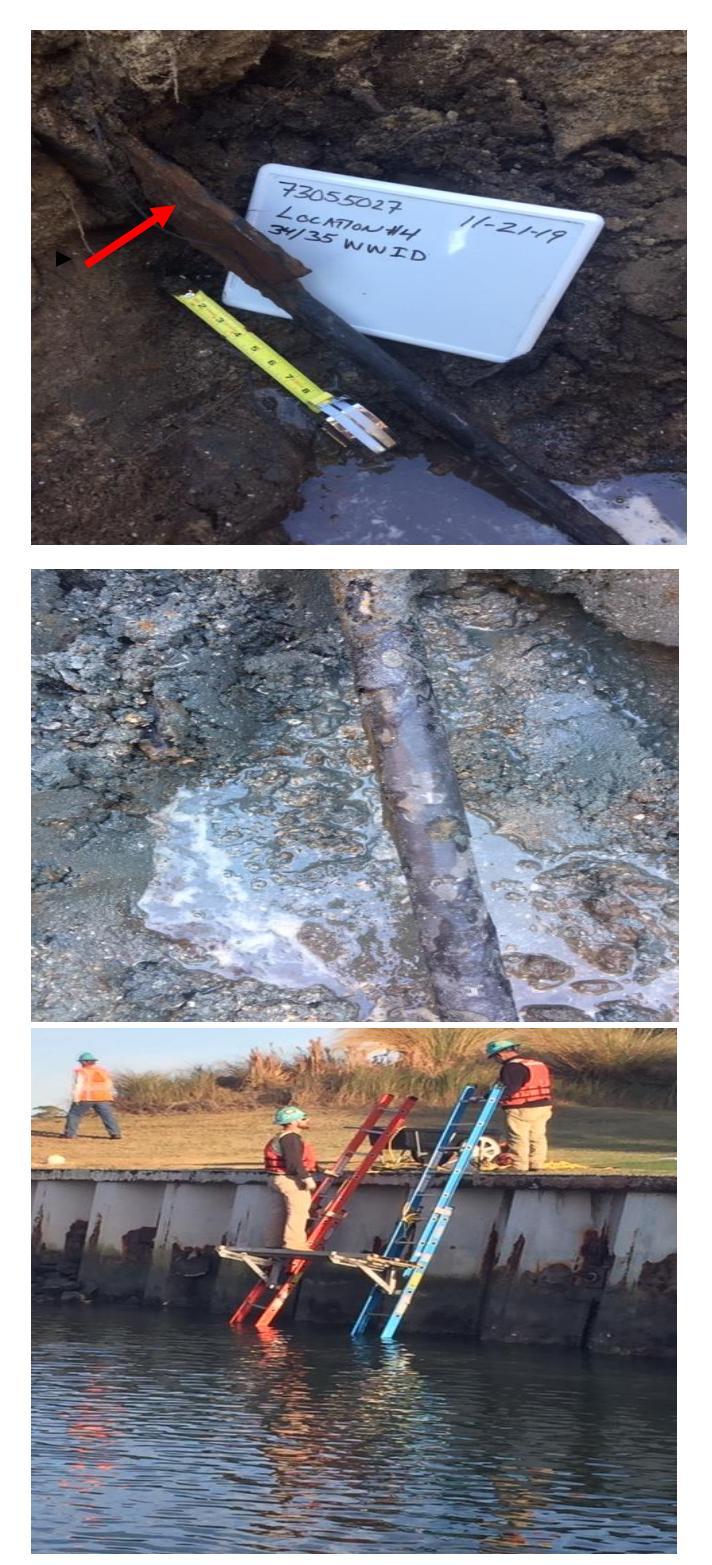
**Photo #10** Location #4, tie rod exposed. Plate visible at left in photo.

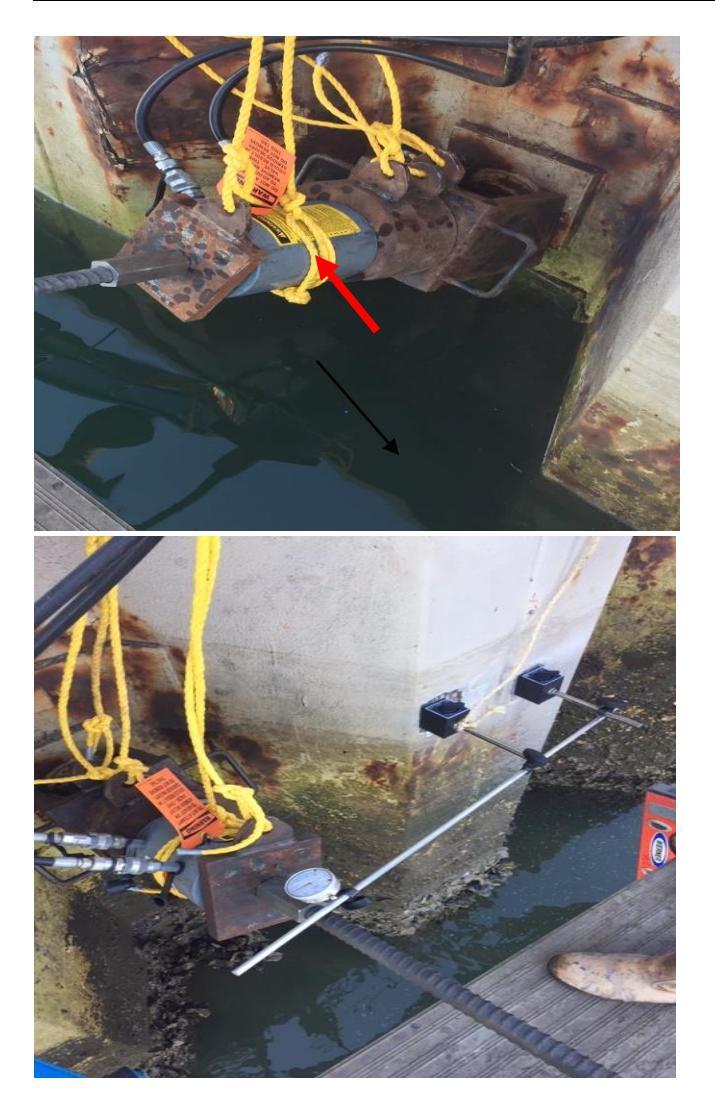
**Photo #13** Location #1, Typical pullout test equipment setup. Arrow points to jack
